Project Name: South Water Tower Rehabilitation Zip Code: 45322

On May 10, 2022, Dixon Engineering Inc. performed a maintenance inspection on the 1,000,000 gallon spheroid (South Tank) elevated water storage tank owned by the City of Englewood. Purposes of the inspection were to evaluate the interior and exterior coating's performance and life expectancy, assess the condition of metal surfaces and appurtenances, review safety and health aspects, and make budgetary recommendations for continued maintenance of the tank. All recommendations with budgeting estimates for repairs are incorporated in this report.

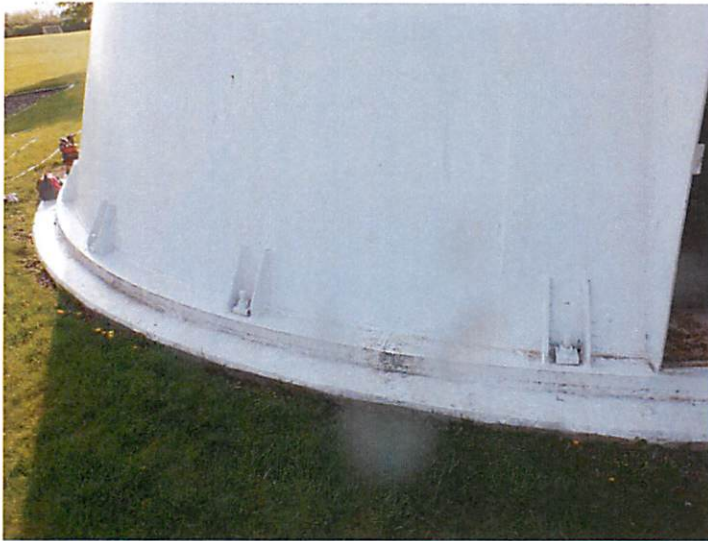
1) The concrete foundation is in good condition.

Recoat the exposed concrete with an epoxy coating system to help prevent deterioration. The cost would be incidental to the next painting project.

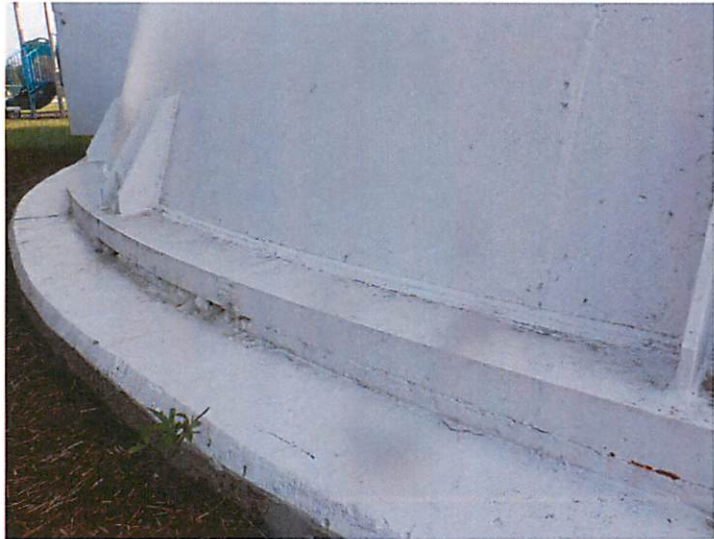
2) The grout between the steel foundation and the concrete baseplate is in good condition.

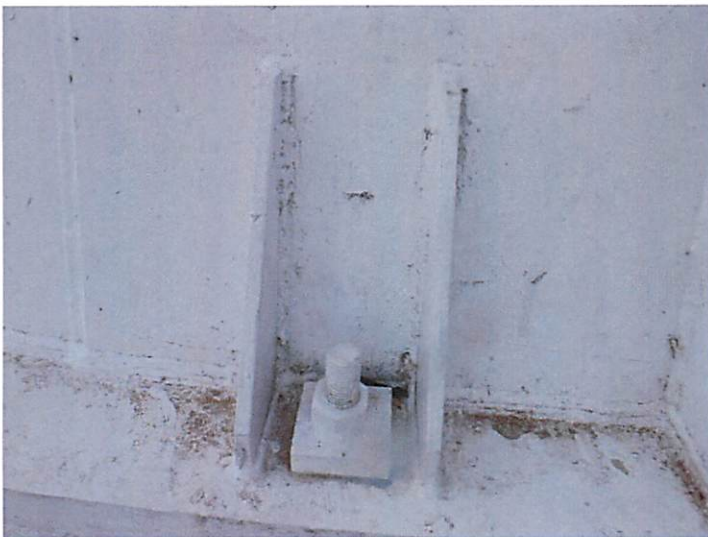
3) The basebell anchor bolts are in good condition.

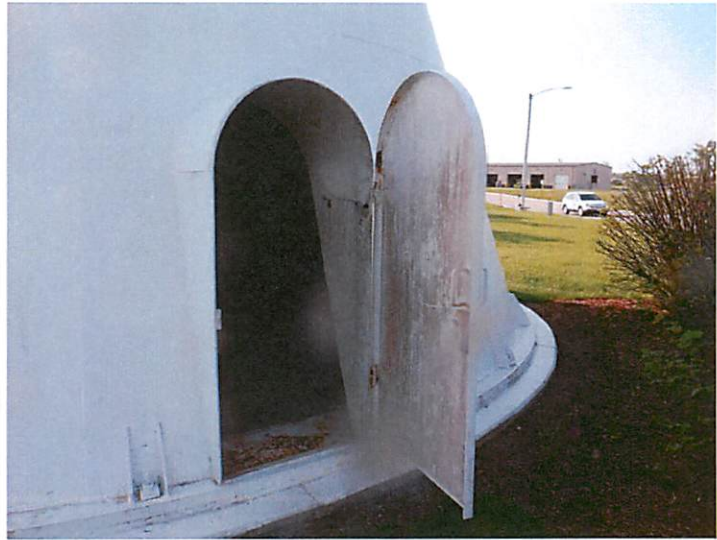
5) The service door operated properly during the inspection.

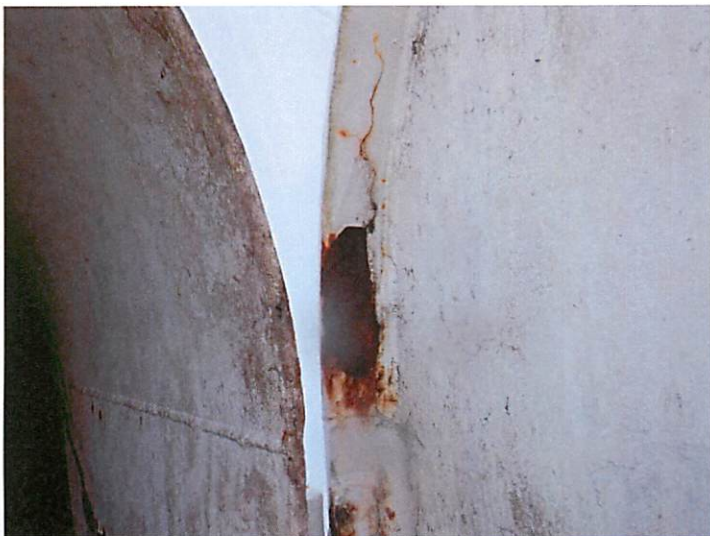
6) There are coating failures on the door.

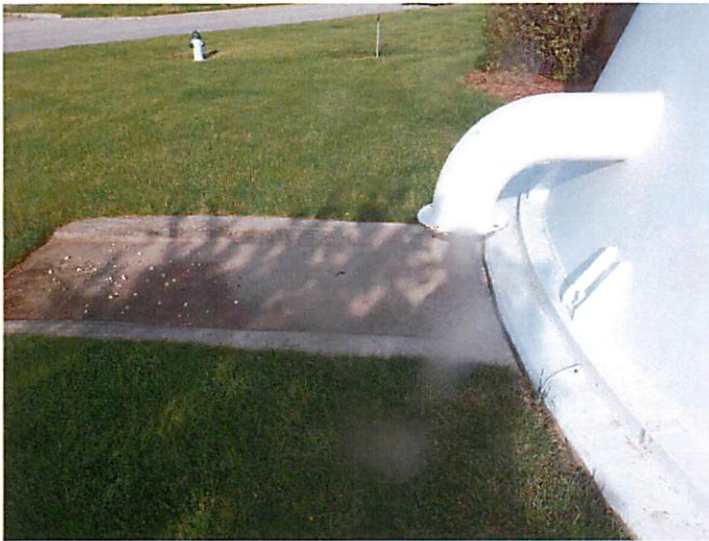
7) The overflow pipe discharges to concrete splash pad.

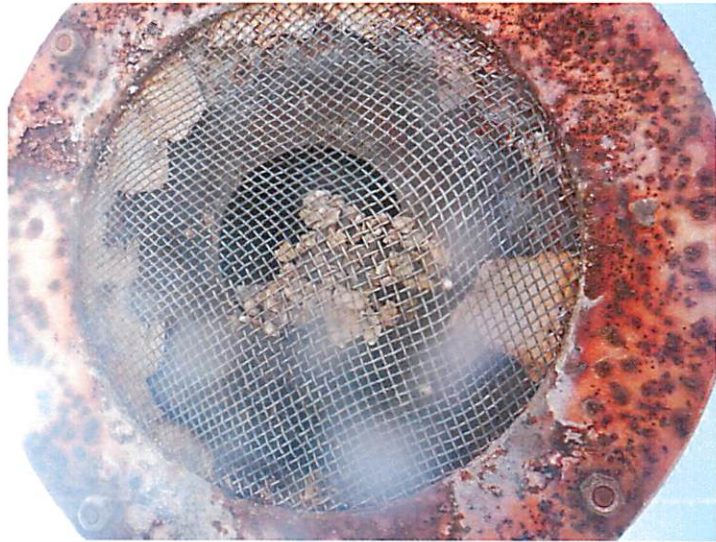
8) The overflow screen is in good condition. There are coating failures on the flange.

Install a screened flap gate discharge. The flap gate would allow water to discharge even if the screen becomes covered with debris or frosted over. The gate is designed to stay closed to prevent rodents or birds from entering the pipe. The screened flap gate would allow water out but prevent debris from clogging the discharge. The estimated cost is \$3,000.

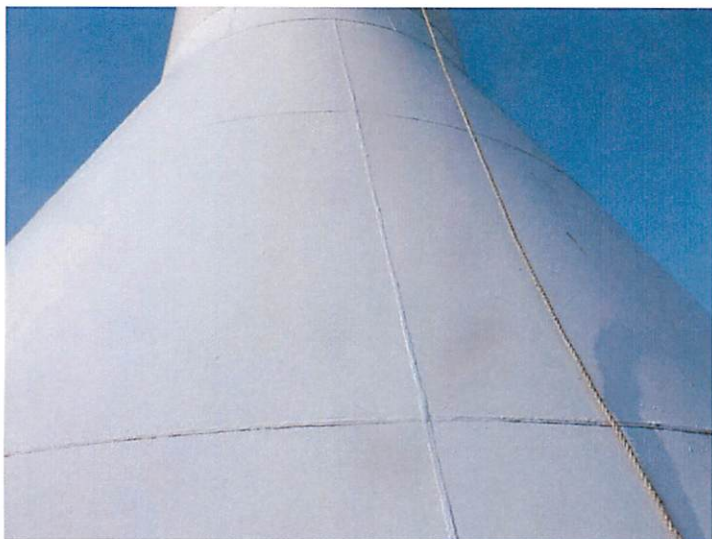
9) The coating on the basebell is in good condition with minor spot failures.

Remove the existing coating by dry abrasive blast cleaning the steel to a commercial (SSPC-SP6) condition and apply a urethane system. All blast work would be performed inside a dust tight containment system using negative air pressure.

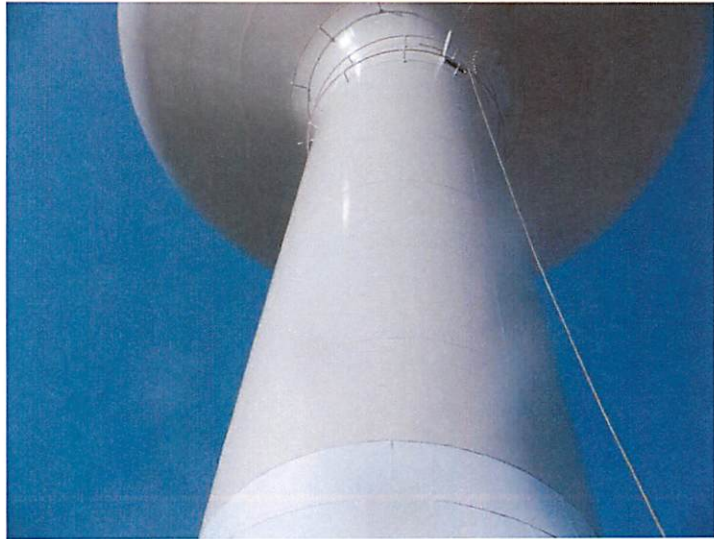
11) The coating on the riser is in good condition.

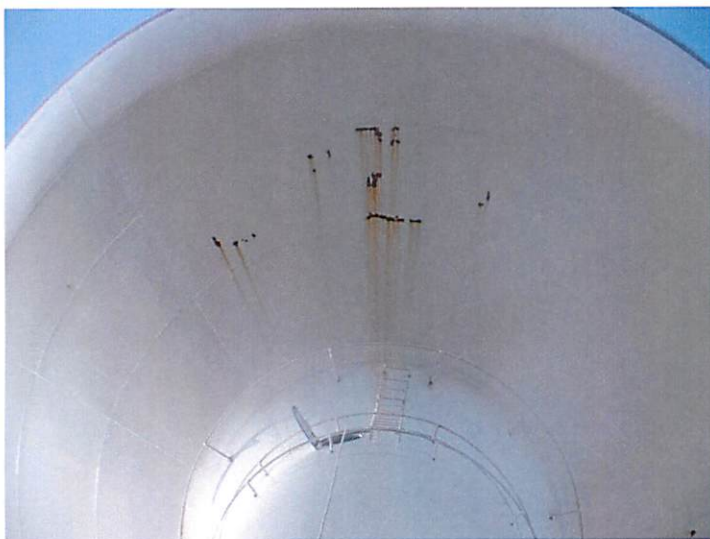
12) The coating on the bowl is in fair condition with minor spot coating failures.

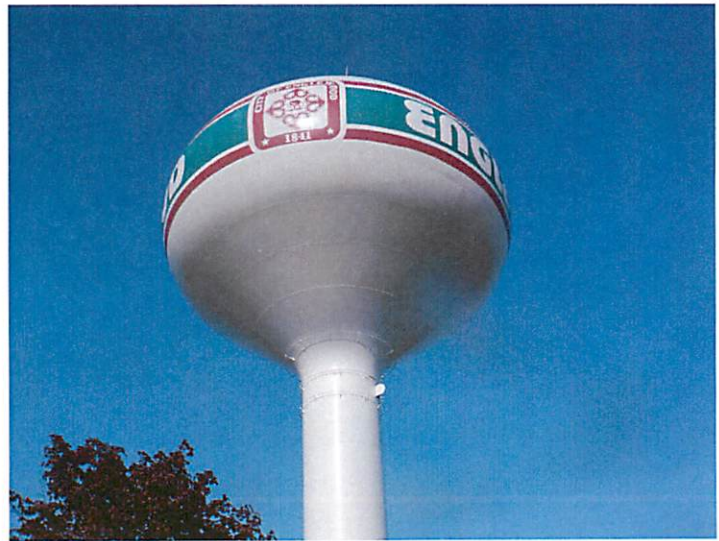
14) The coating on the sidewall is in good condition.

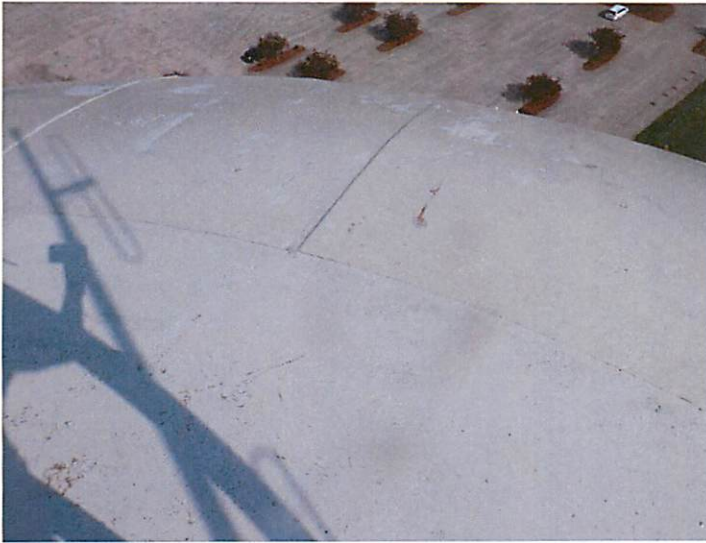
16) The coating on the roof is in fair condition with moderate failures.

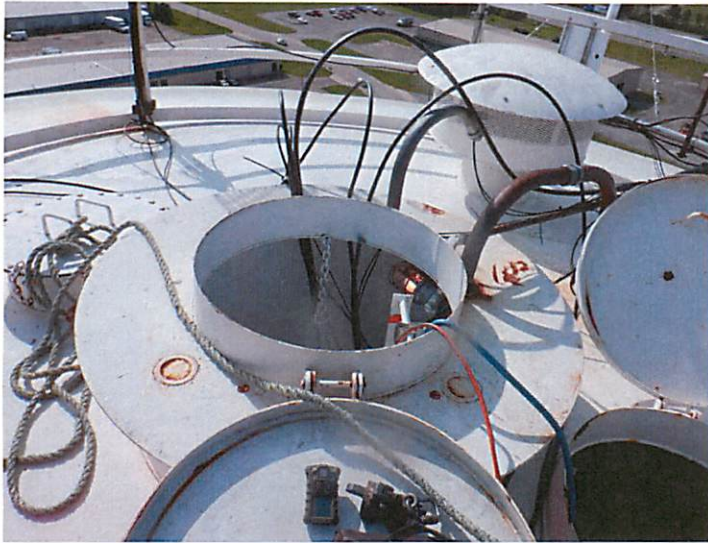
19) The dry interior hatch is in good condition.

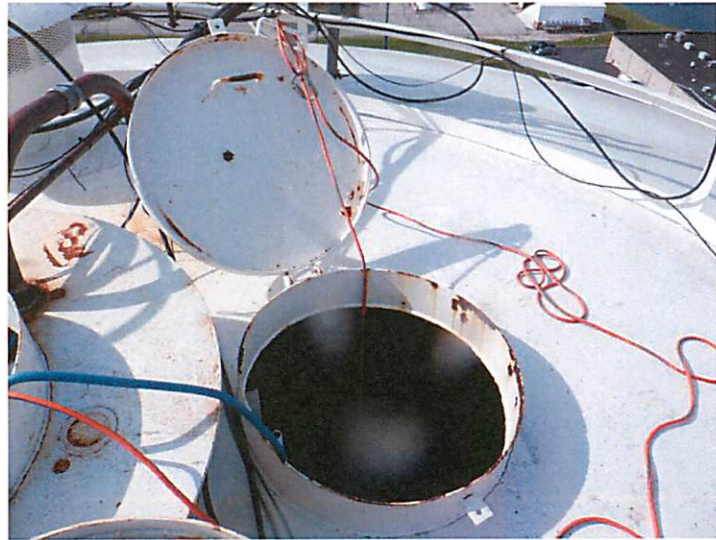
20) The wet interior hatch is in good condition. There was no gasket on the hatch.

1. Install a gasket on the wet interior roof hatch to meet current Ohio EPA requirements. The cost would be incidental to the next painting project or could be performed by in-house personnel.
2. Replace the roof vent with a pressure vacuum vent that has a rain shield to meet current Ohio EPA requirements. The estimated cost is \$6,000.

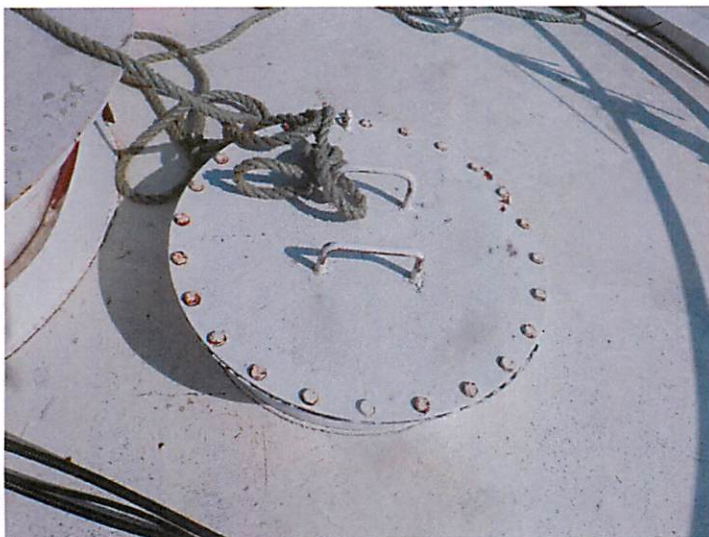
21) The bolted ventilation hatch is in good condition.

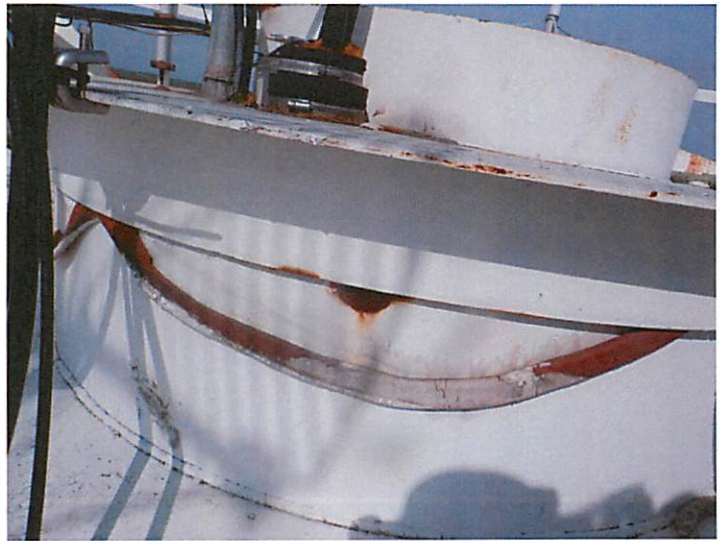
23) The access tube air gap was sealed with a gasket wedged into the opening. The gasket has come loose.

3. Replace the cover over the access tube air gap to meet current Ohio EPA requirements. The cost would be incidental to the next painting project.
4. Install a sample tap on the fill/draw pipe to meet current Ohio EPA requirements. The estimated cost is \$1,000.

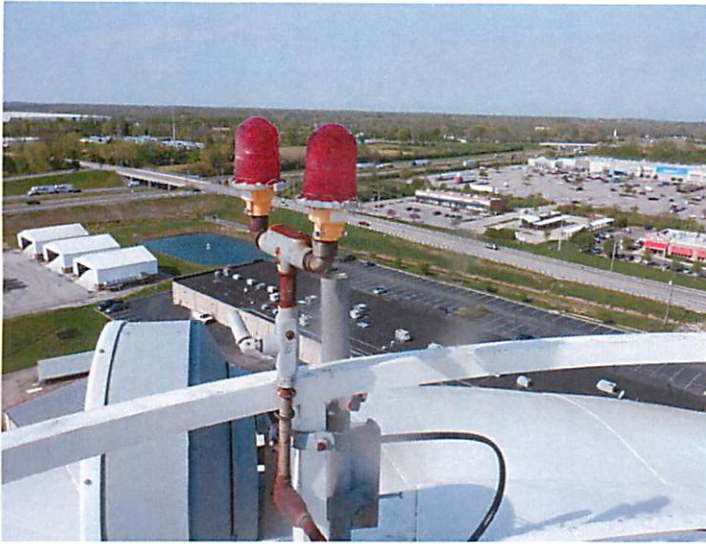
25) The double aviation light appears to be in good condition.

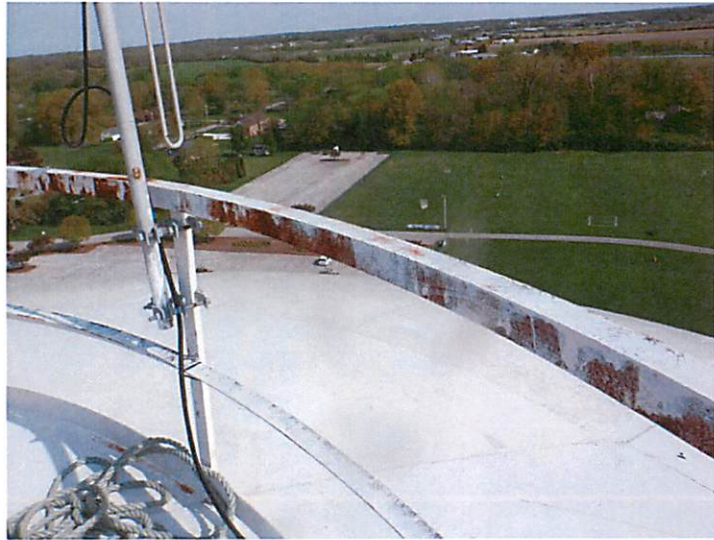
26) The roof handrail is in good condition. There are coating failures on the railing.

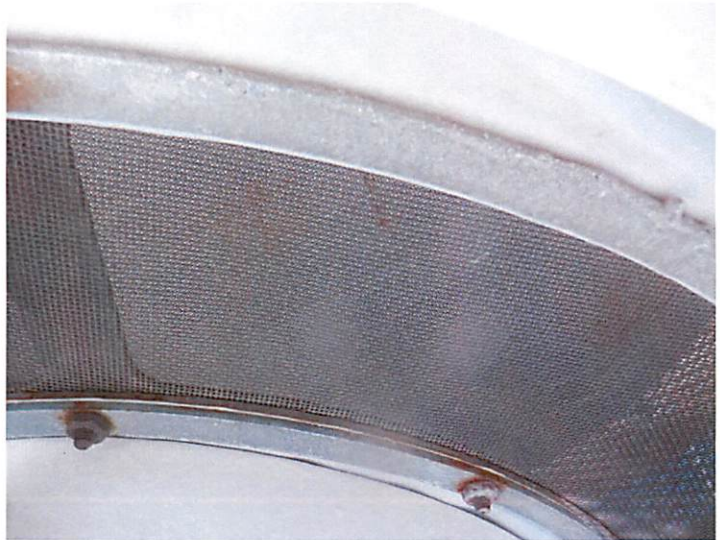
32) The screened pressure plate was found to be in good condition.

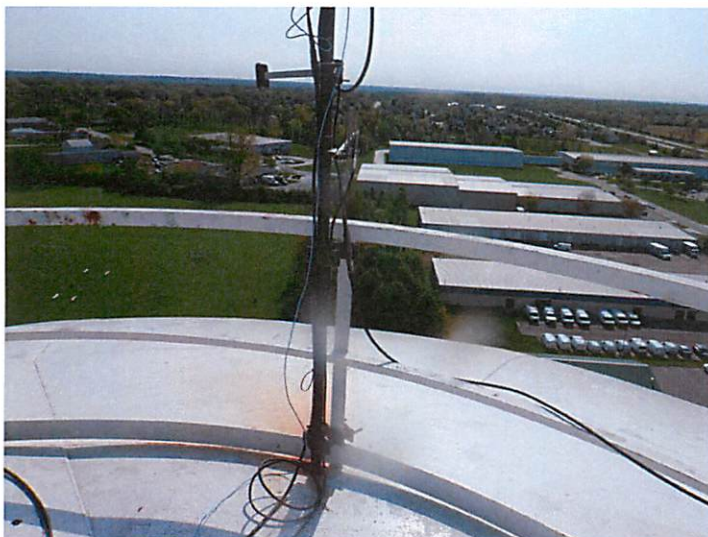
33) Antennas are mounted to the roof handrail.

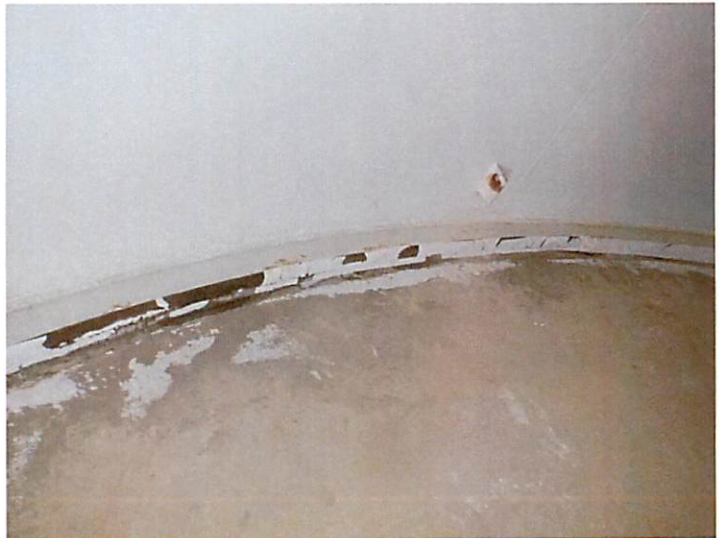
35) The basebell coating is in good condition with delamination on the baseplate.

Spot abrasive blast clean the dry interior to a commercial (SSPC-SP6) condition including the topside of the platforms and other areas of failed coating. The prepared surfaces would be coated with an epoxy system. The work should be performed with an exterior painting project. The estimated cost is \$20,000.

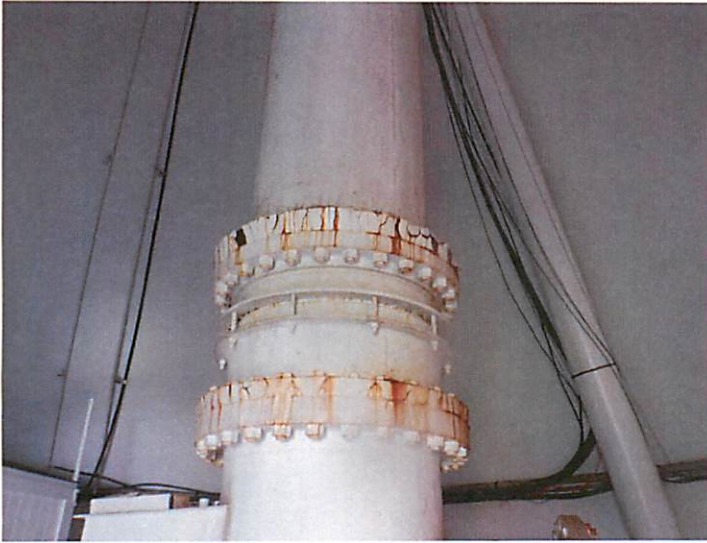
37) There is a glandular expansion joint on bottom of fill/draw pipe. The joint appears to be in good condition.

11. Remove the glandular expansion joint on the fill/draw pipe and replace with a bellows type joint. The estimated cost is \$8,000.
12. Install a mud valve in the bottom of the tank. The estimated cost is \$5,000.

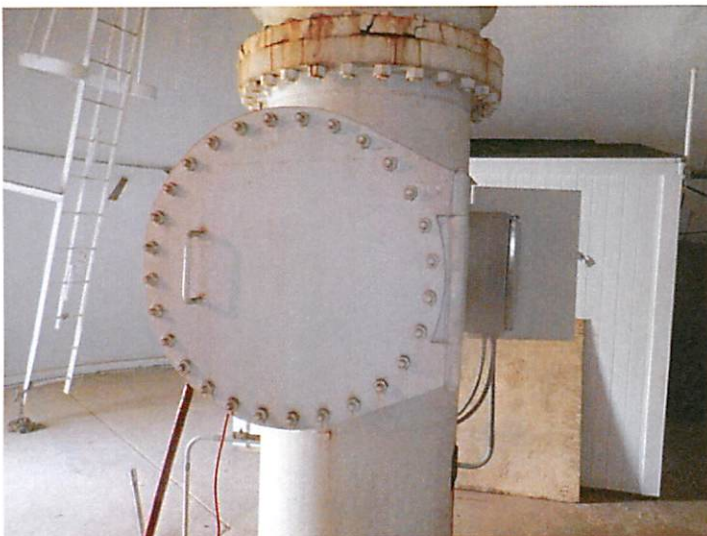
39) The fill/draw pipe manway is in good condition. The fill/draw pipe is not insulated in the dry interior.

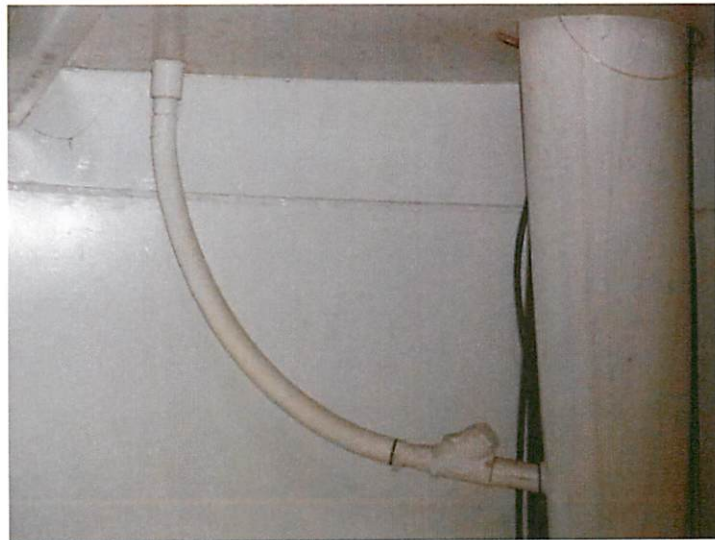
41) The condensate platform drain line is in good condition. The check valve appears to be in good condition.

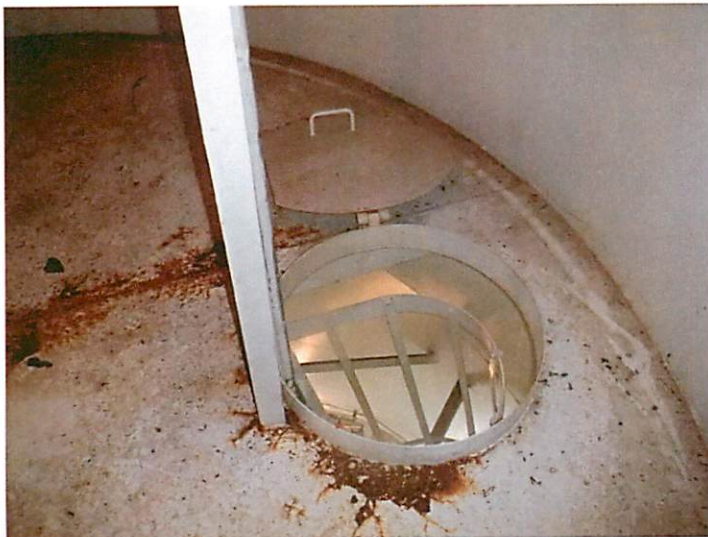
42) The condensate platform opening is equipped with a hinged cover.

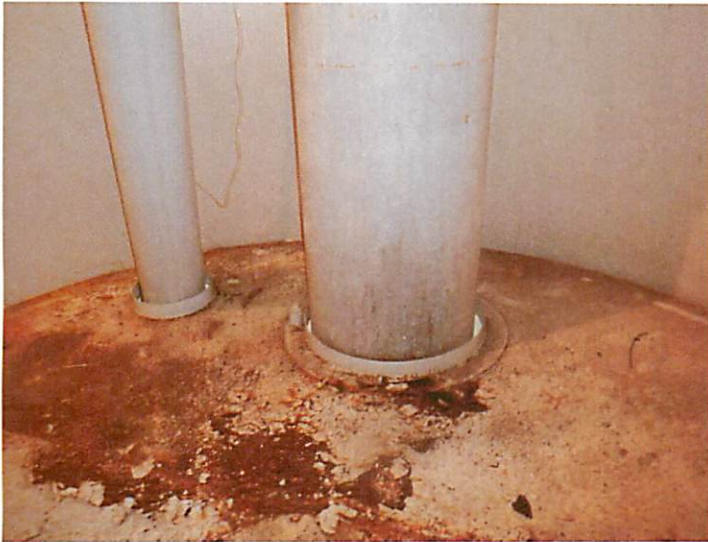
43) The condensate platform coating is in poor condition.

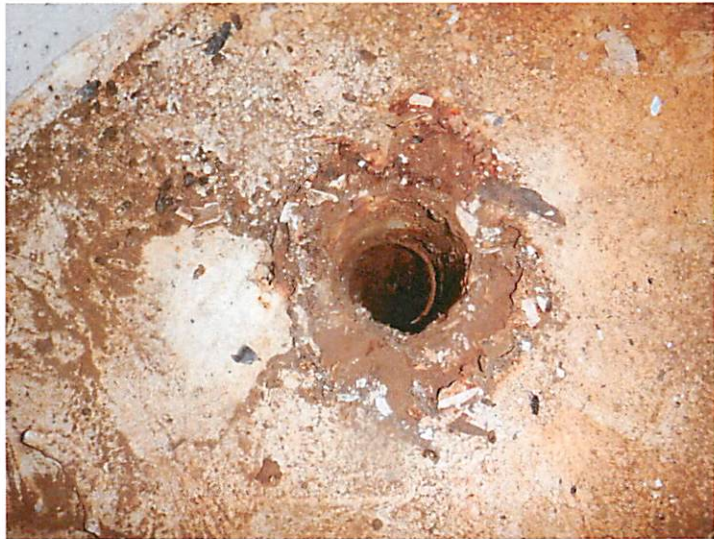
44) The condensate platform drain appears to be in good condition.

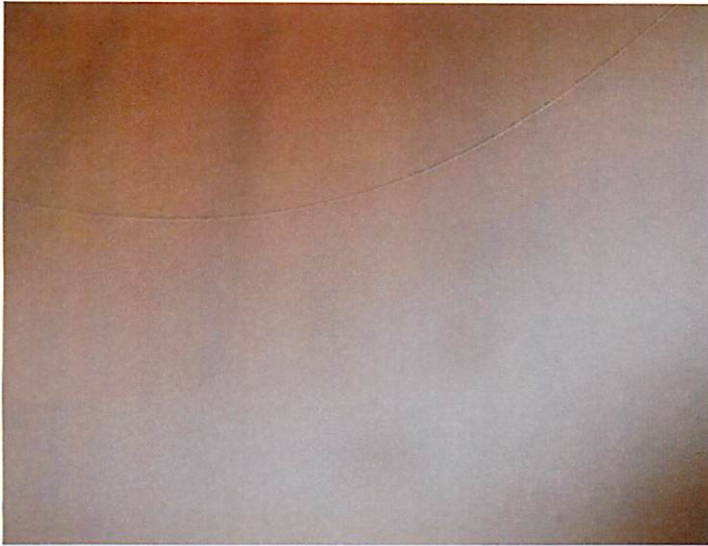
46) The coating in the riser is in good condition.

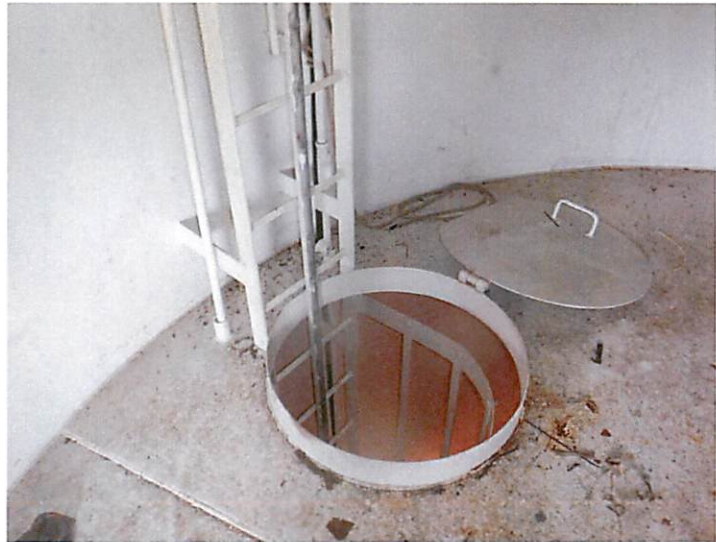
47) The top platform opening is equipped with a hinged cover.

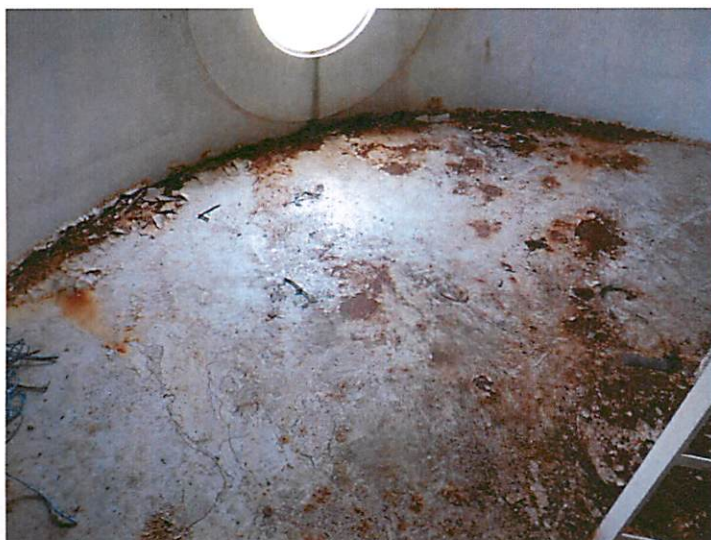
48) The coating on the top platform is in poor condition.

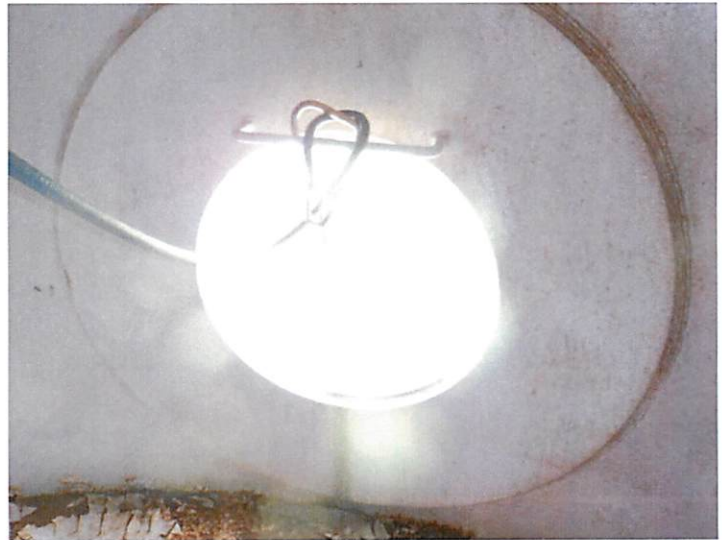
50) The painter's hatch at the top of the riser is in good condition. There is a handhold over the opening.

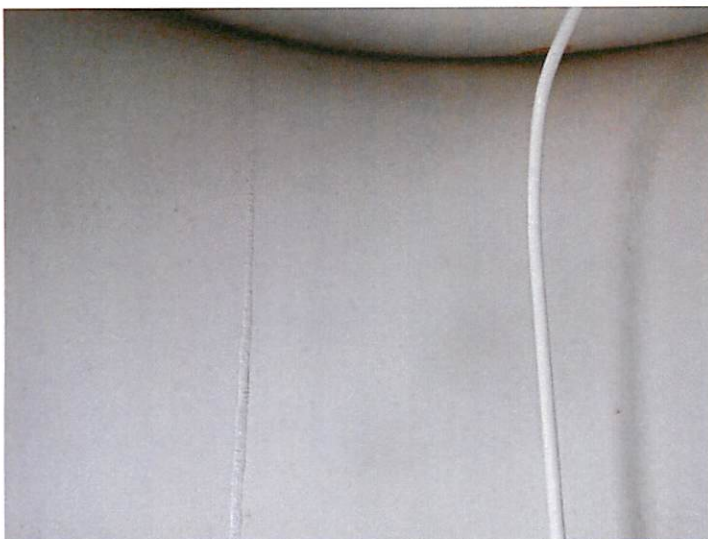
51) The coating on the riser above the top platform and the bowl is in good condition with minor failures.

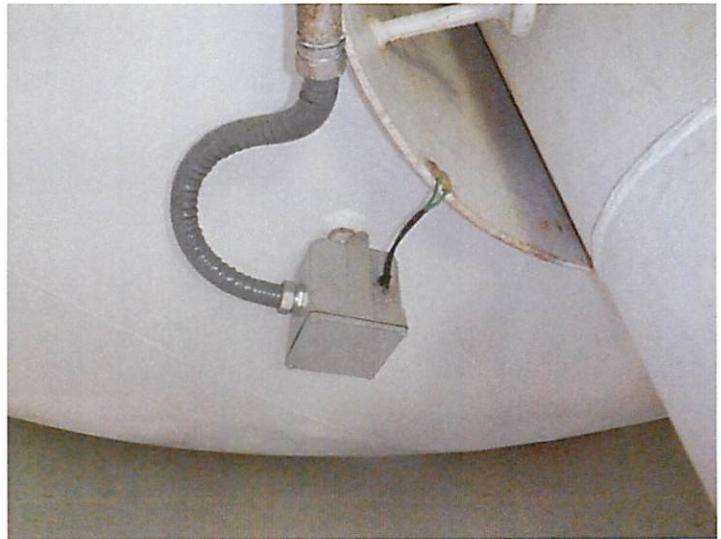
53) The pressure fitting for cathodic protection appears to be in good condition.

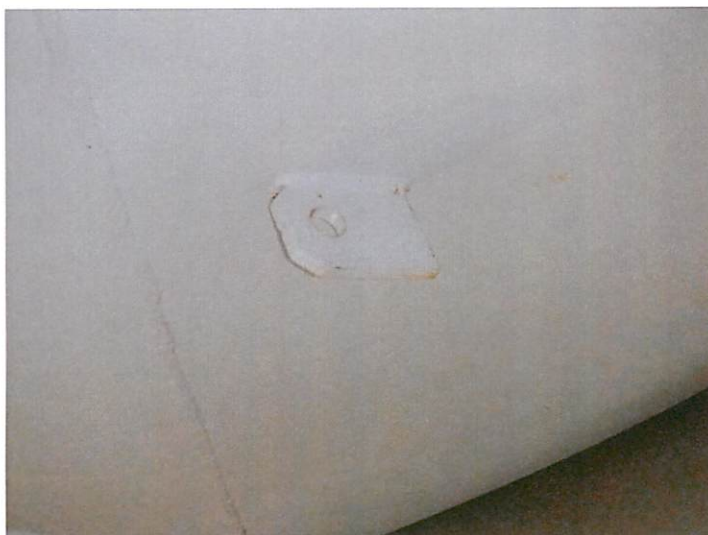
54) The rigging lug on the bowl above top platform hatch is in good condition.

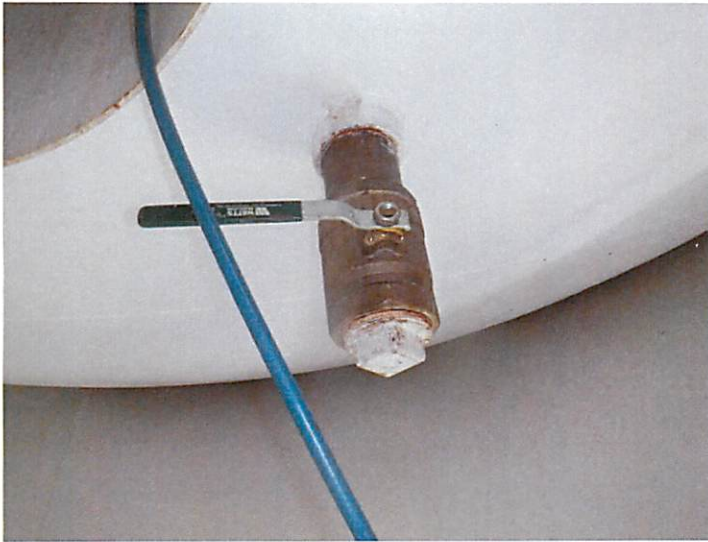
55) There is a plugged drain valve in the bowl.

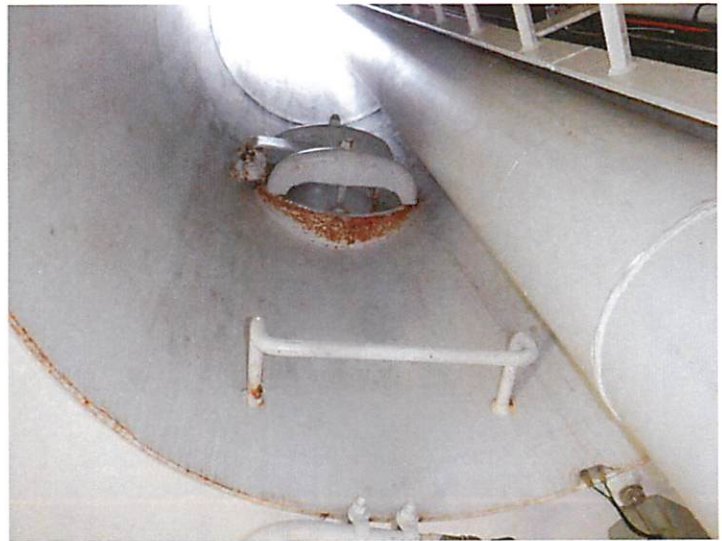
56) The wet interior manway located in the access tube is in good condition.

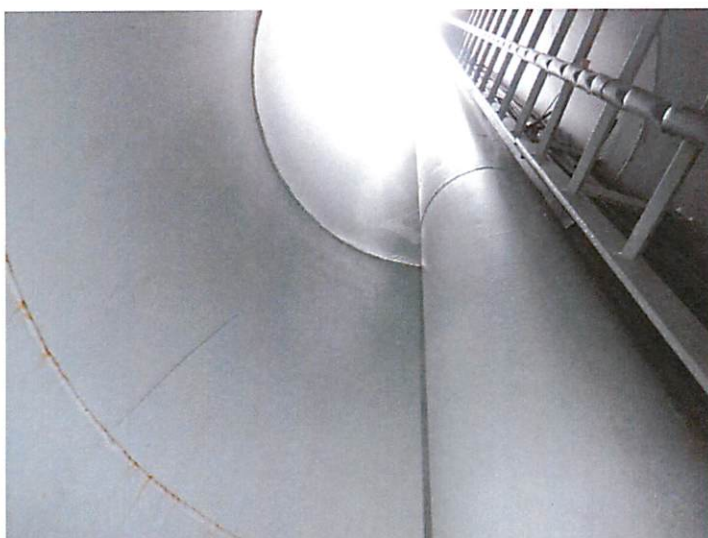
57) The access tube coating is in good condition.

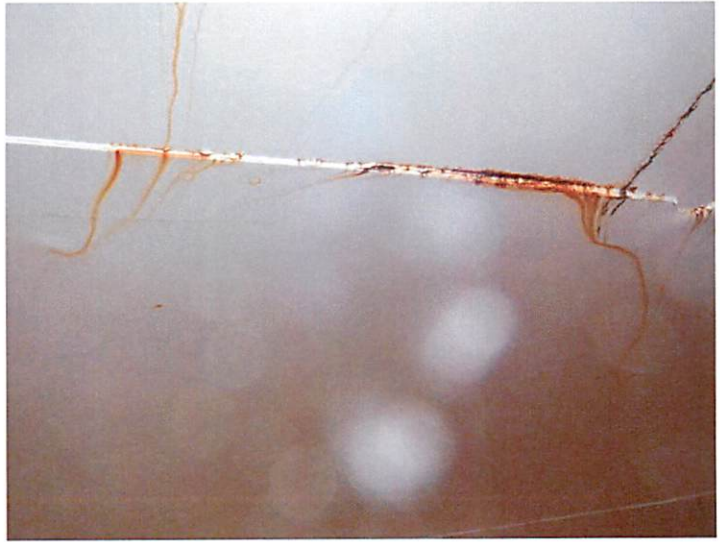
59) The wet interior roof coating is in good condition.

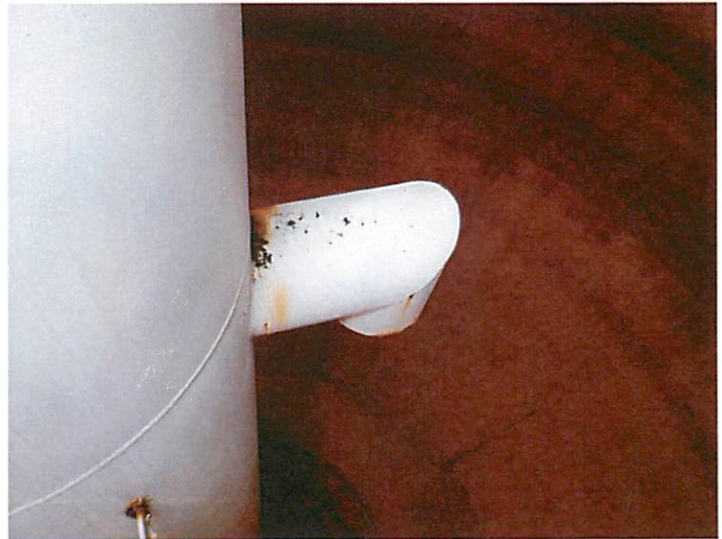
62) The overflow pipe elbow is in good condition.

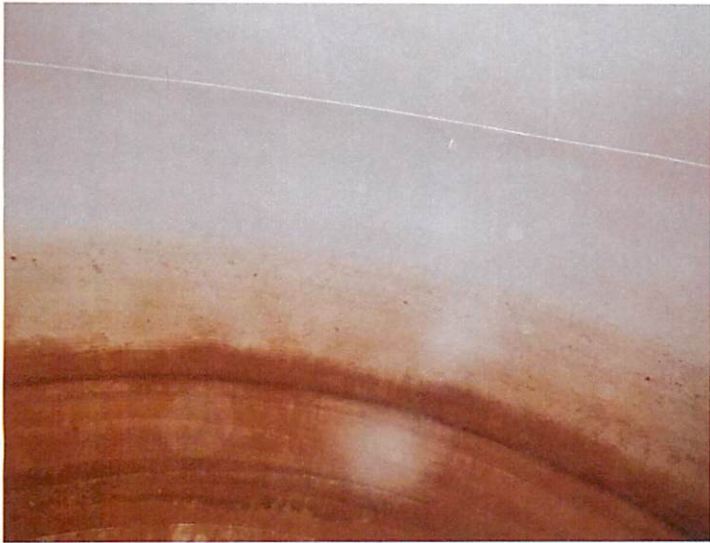
64) The coating on the sidewall is in good condition.

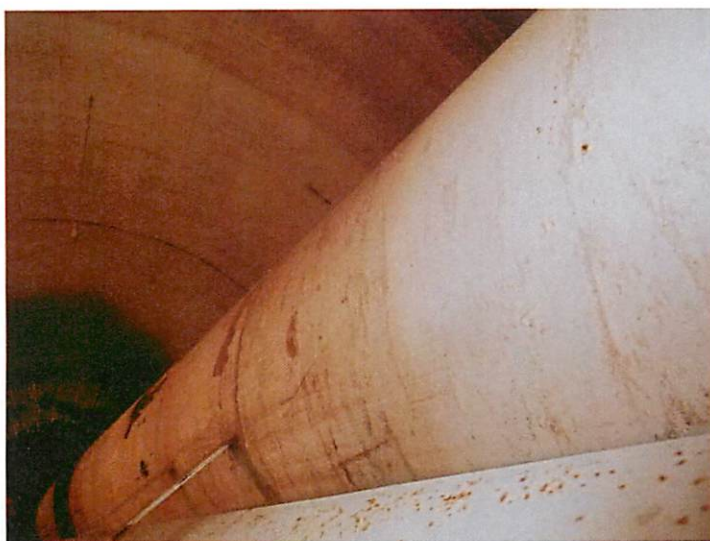
66) The coating on the access tube is in fair condition.

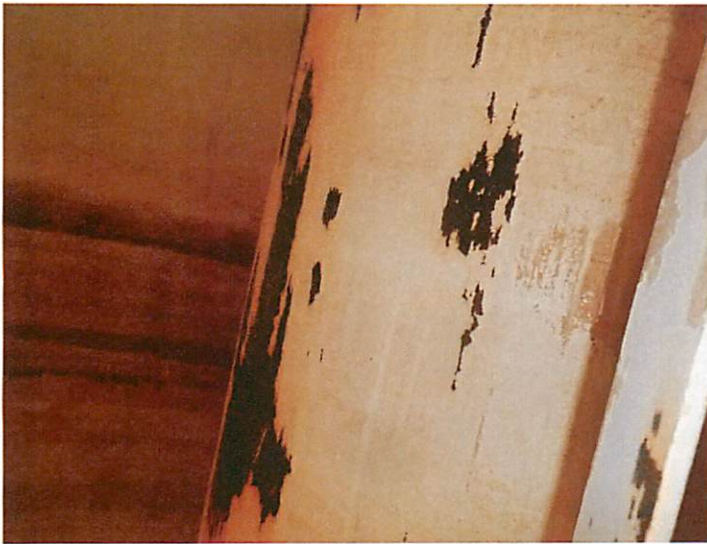
67) There is coating damage on the access tube likely from ice movement.

The existing coating system has not deteriorated to the point where replacement is warranted. The cathodic protection system should adequately protect all areas below the high-water level where the coating has deteriorated. Reinspect in five years to update conditions and recommendations. Long term budget to repaint in ten years. The estimated cost is \$240,000.

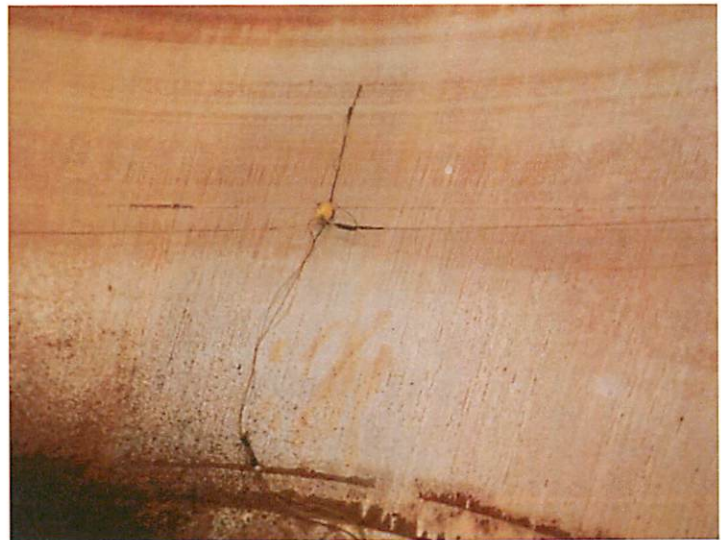
68) The cathodic protection system appears to be in good condition.

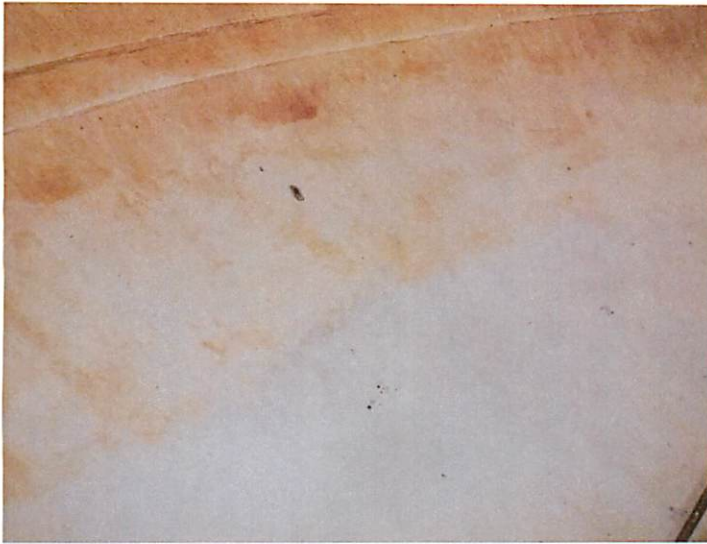
70) The coating on the bowl is in good condition overall with a few minor spot coating failures.

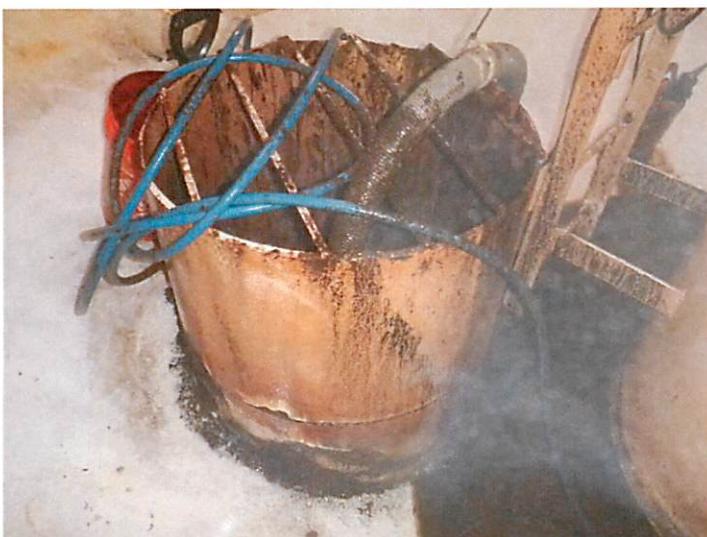
72) The fill/draw pipe is in good condition. There are deflector bars over the top of the pipe.

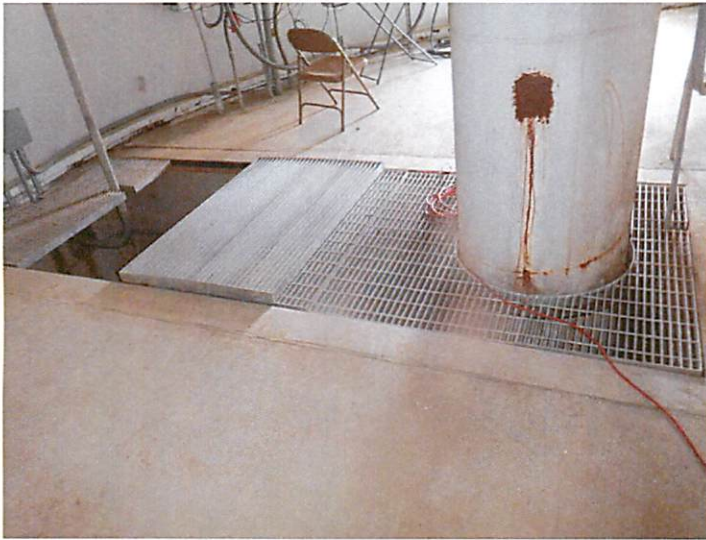
73) There is piping located in a pit in the basebell. The pit cover is in good condition.

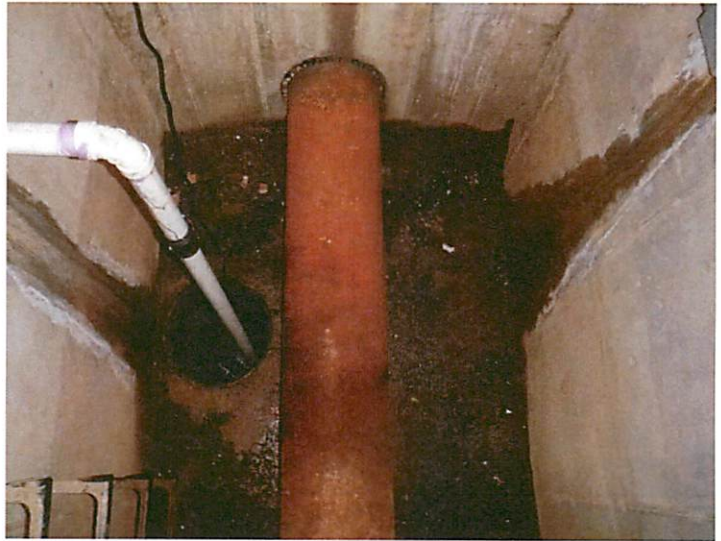
74) The coating on the pit piping is in fair condition.
