Public Works Commission

Application for Financial Assistance

Project Name: Far Hills Storm Sewer Reconstruction Zip Code: 45419

FAR HILLS STORM SEWER RECONSTRUCTION PROJECT
OVERALL PROJECT MAP

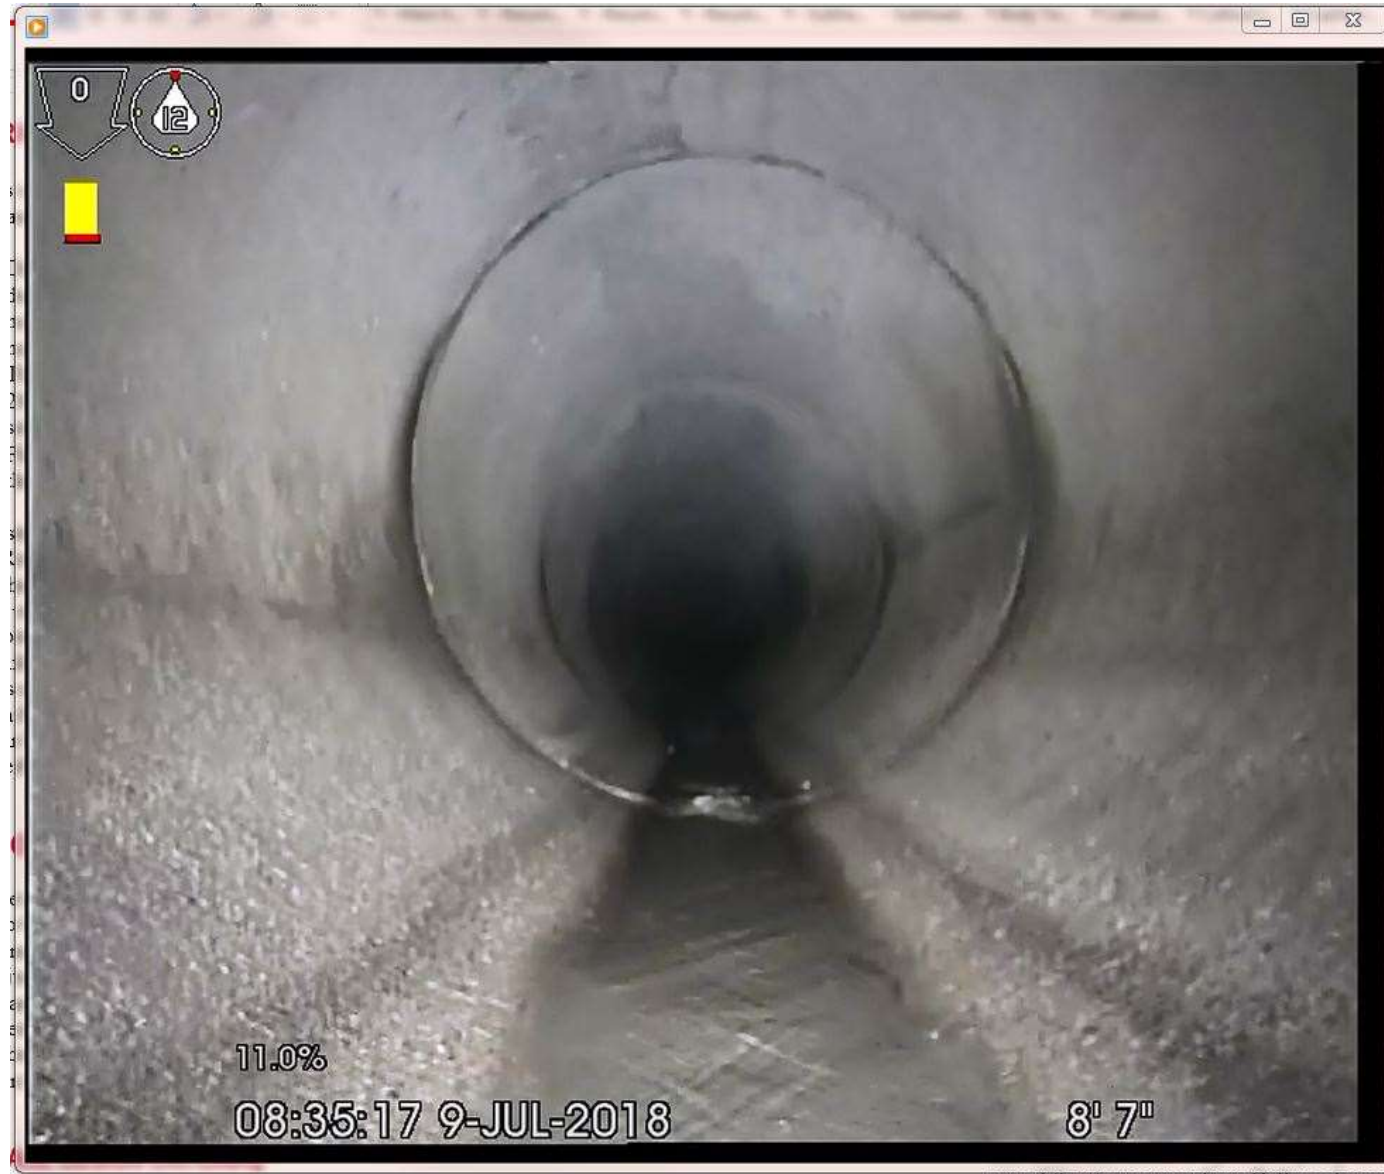
Exhibit 1

36" REINFORCED CONCRETE PIPE

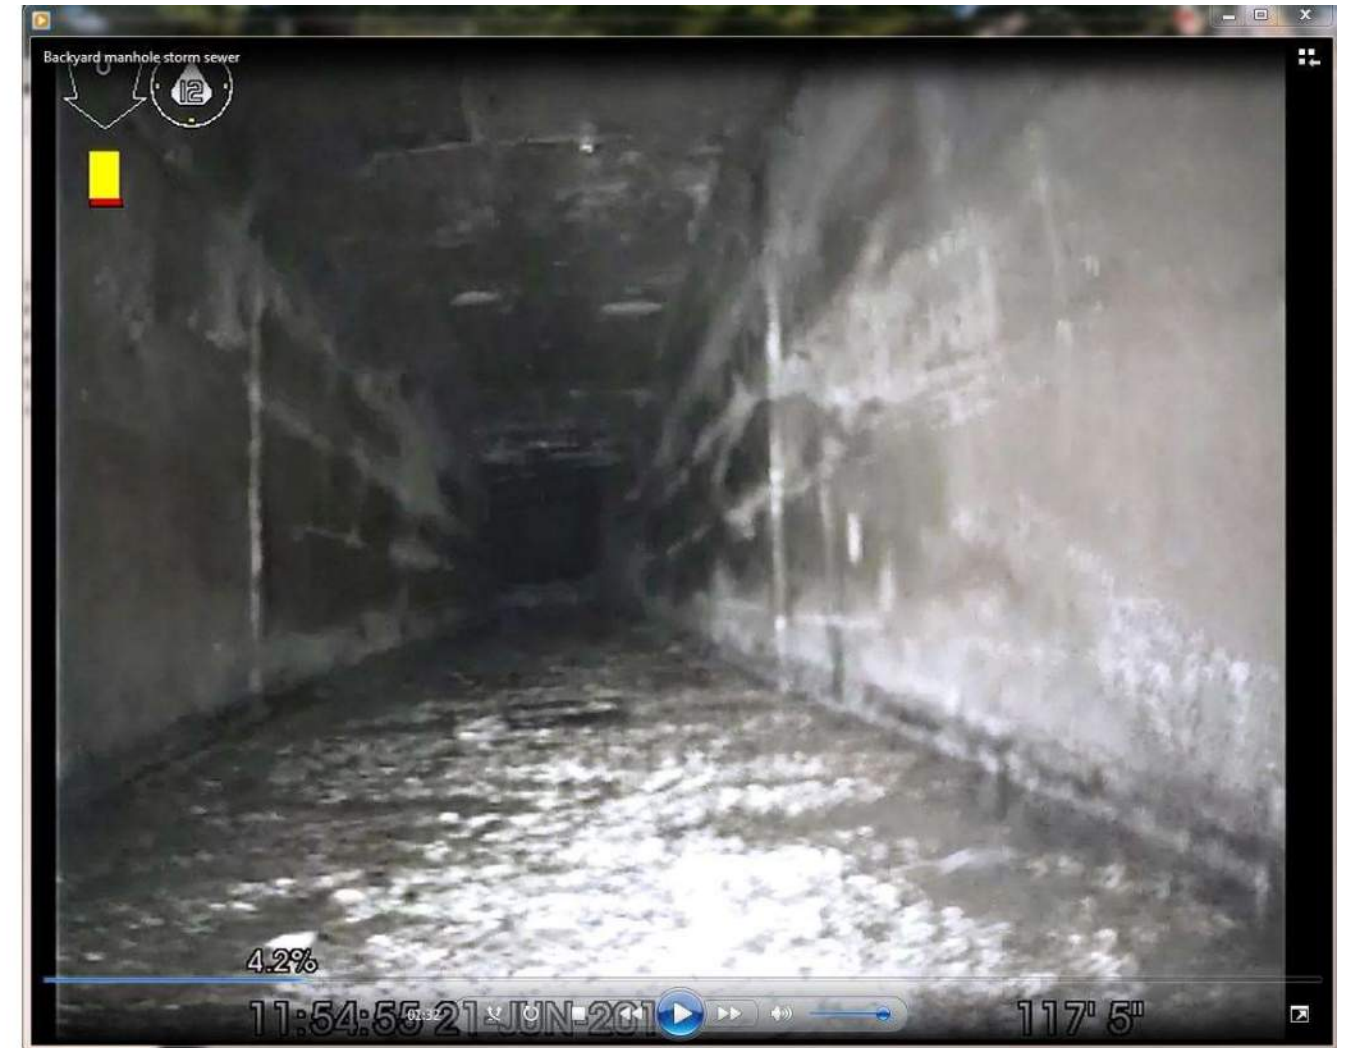
Exhibit 2

3' x 3' REINFORCED CONCRETE BOX CULVERT
BENEATH THE HOUSE at FAR HILLS AVENUE

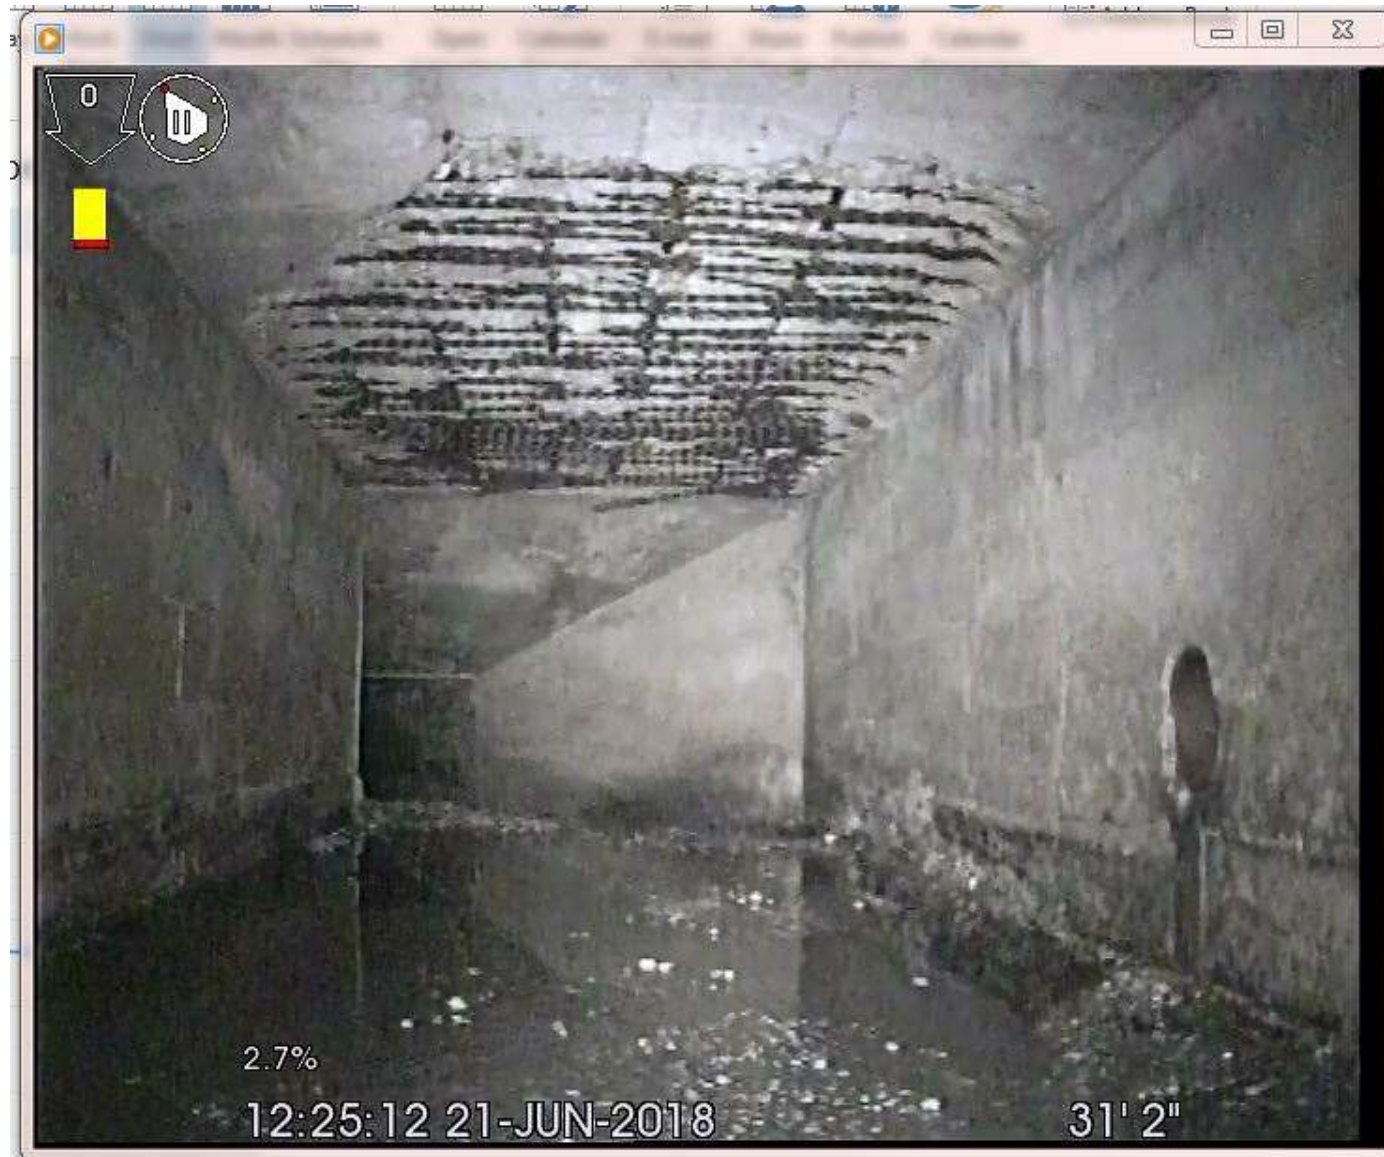
Exhibit 3

The box culvert in the area behind the west curb line of Far Hills Avenue has a section where the concrete on the roof has spalled away, exposing the reinforcing steel and leaving it exposed and deteriorating (See Exhibit 3). This is symptomatic of salt intrusion into the concrete interacting with the steel reinforcement, which expands and pops the concrete cover off. It is difficult to estimate the length of the damage from the video, but the entire width of the roof is clearly damaged and in poor condition. This area coincides to the area where snow plows would deposit salted snow from the pavement during winter conditions. The construction of the box culvert probably included waterproofing for the section of box culvert under the roadway, but not beyond. The city should consider a temporary repair of this section if the box culvert cannot be replaced in the near future. There is also a large chunk of what appears to be concrete, estimated at 9" thick and 3.5 feet wide, immediately downstream (See Exhibit 4). It is recommended to be removed, if possible.

3' x 3' BOX CULVERT – WEST CURBLINE OF FAR HILLS AVENUE,
AND FLOWING WEST

If the box culvert cannot be replaced in the near future, the city should consider a temporary repair of the section of box culvert with the failing roof, (See Exhibit 3).

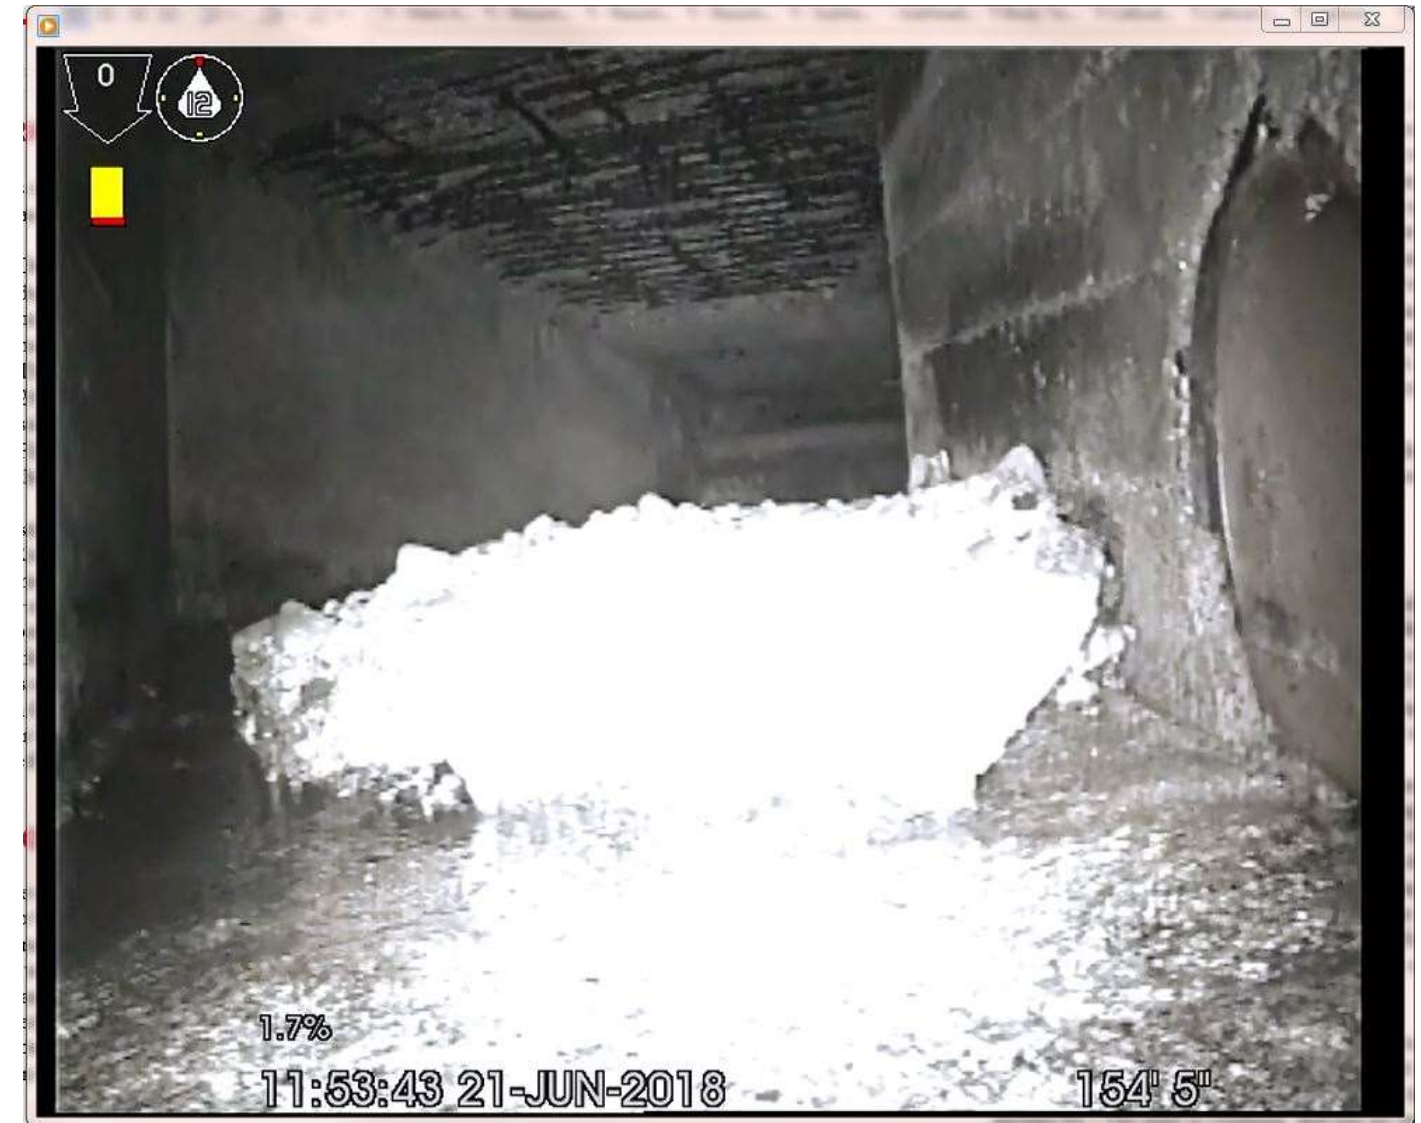
Exhibit 4

CONCRETE DEBRIS in 3' x 3' BOX CULVERT

The large chunk of what appears to be concrete, estimated at 9" thick and 3.5 feet wide, immediately downstream, (See Exhibit 4), is also recommended to be removed, if possible.

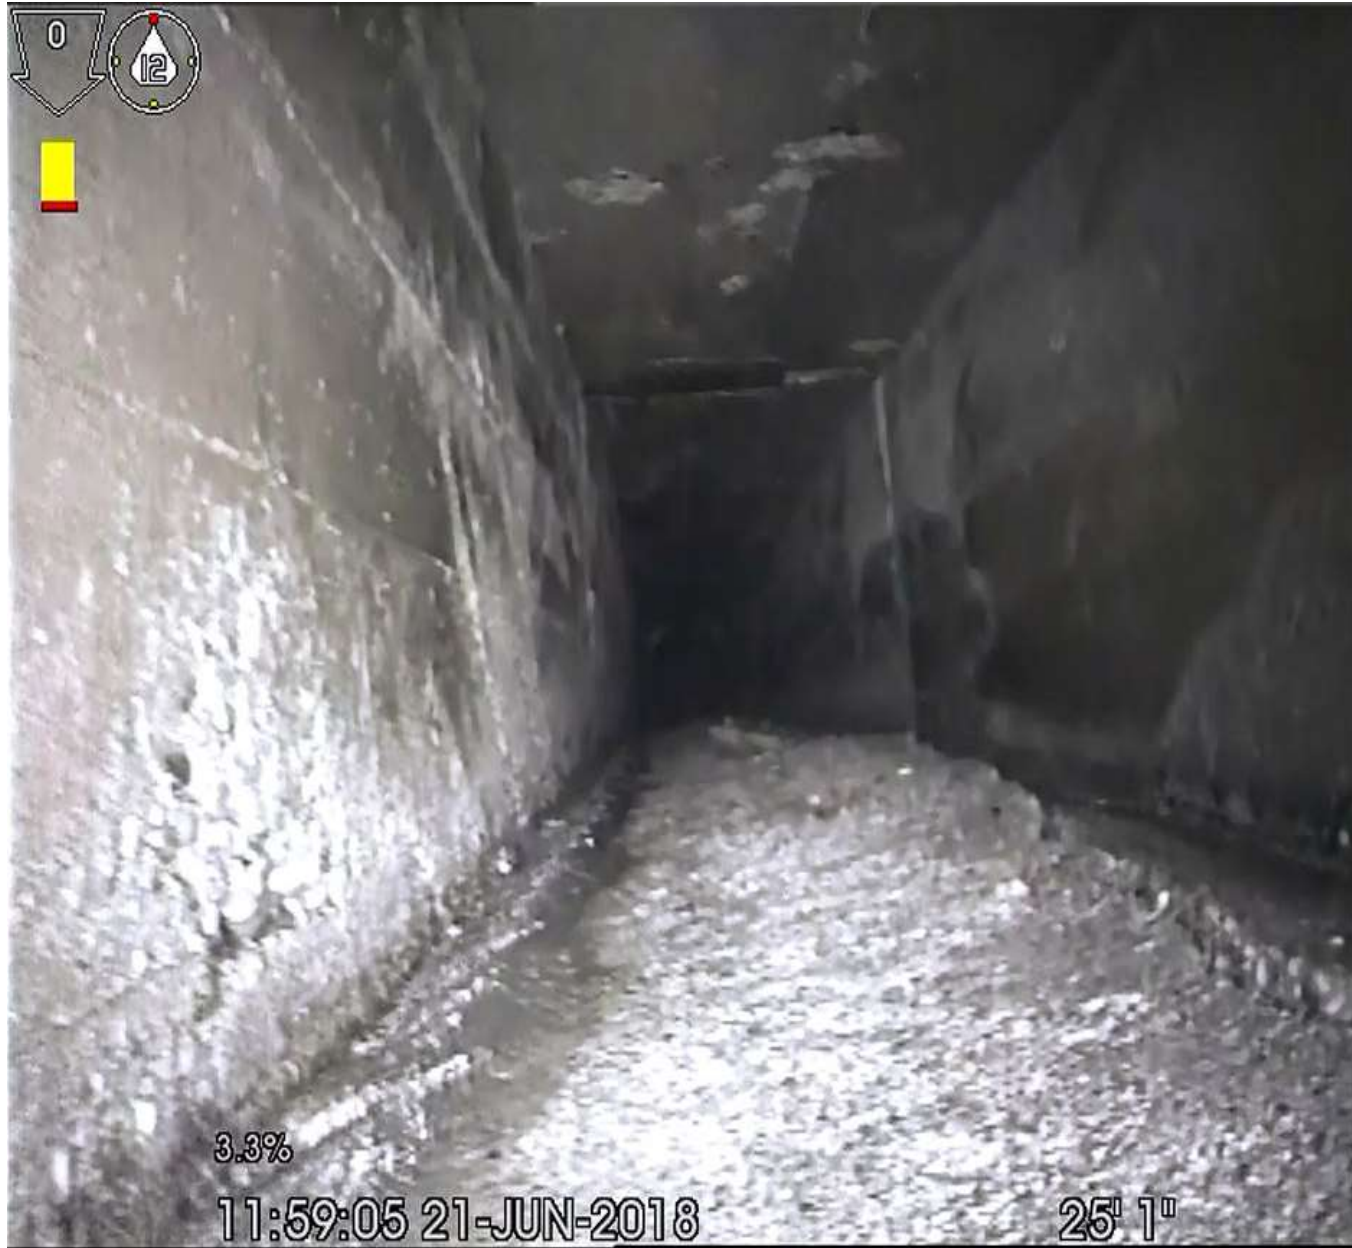
Exhibit 8

The bottom of the box culvert is broken and heaved in the section of box culvert from its downstream connection to the 36" pipe to about 50 feet upstream from the rear yard manhole. It appears the floor of the culvert has failed, and may threaten the stability of the sides and top (See Exhibit 8). It appears the box culvert is nearing the end of its useful life.

3' x 3' BOX CULVERT in STRUCTURAL FAILURE

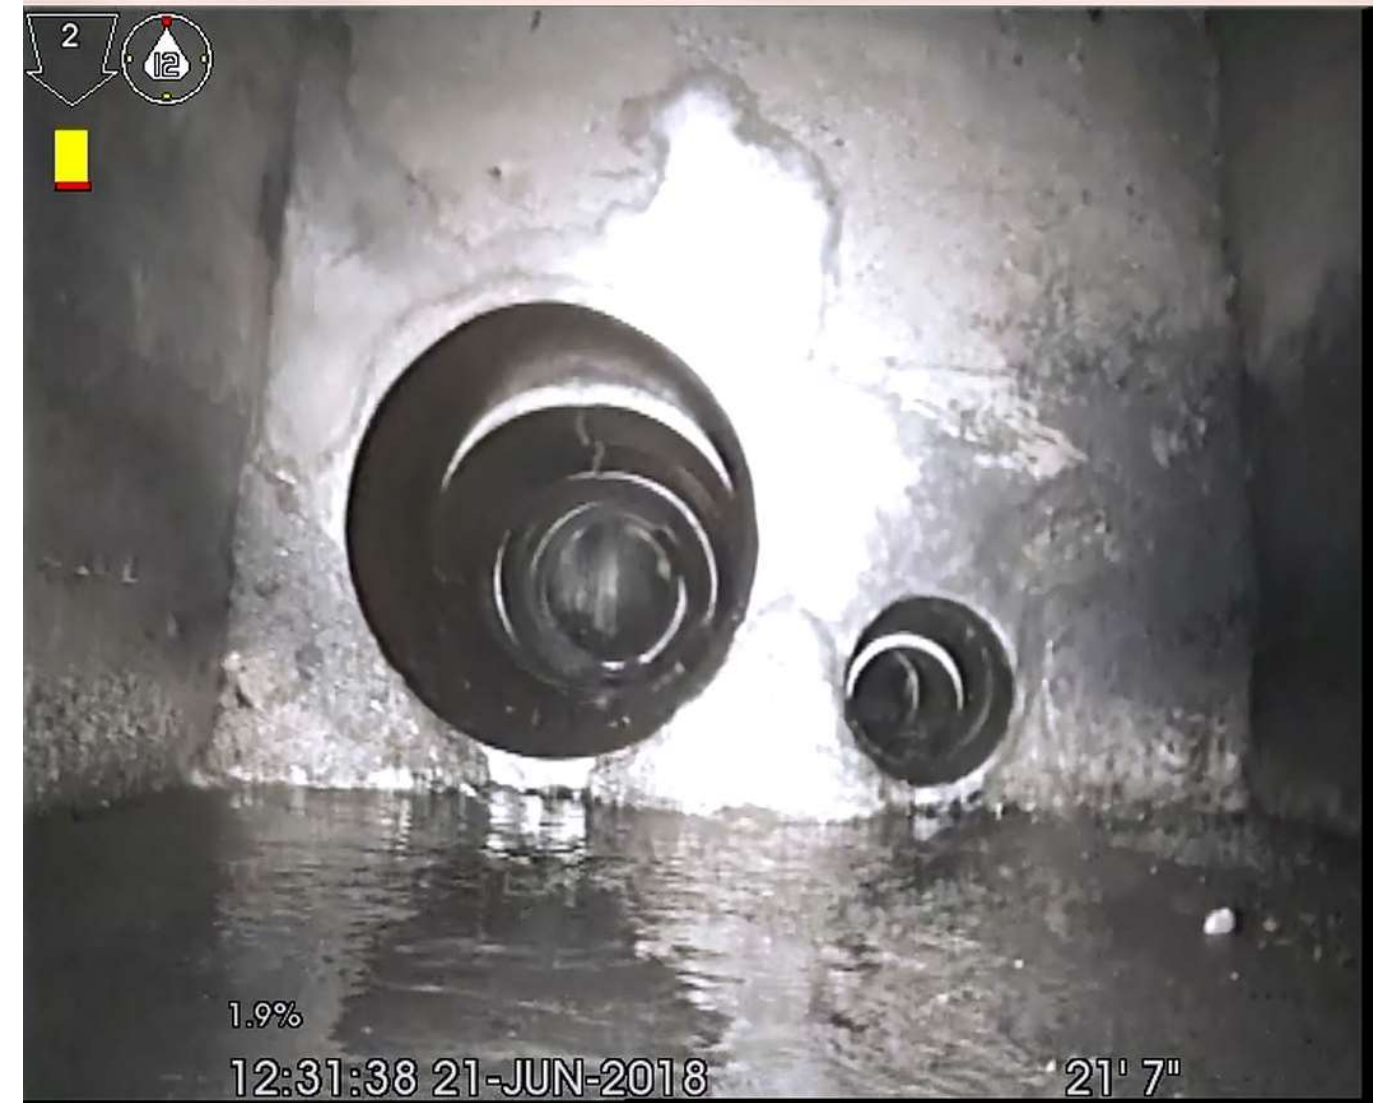
Exhibit 9

At the upstream end of the box culvert, close to the east curb line of Far Hills Avenue, there is an 18" pipe that discharges into the box culvert. In the video, it appears the pipe may be clay pipe. The crown and both spring lines are broken, and the top of the pipe has settled significantly, possibly 1" or 2" or more (See Exhibit 9). The 18" pipe is the larger pipe in the picture. The pipe is crushing, and has no strength in itself. It is only restrained from collapsing by the soil under and beside it up to the spring line of the pipe. The city should consider a repair of this section of pipe if the storm sewer from Dellwood Avenue cannot be replaced in the near future. The smaller pipe to the right is probably a 6" underdrain outlet. It has become misaligned, but does not appear broken, and appears to be at lesser risk of causing immediate problems.

BROKEN 18" CLAY PIPE

If the Dellwood Avenue storm system down to the box culvert cannot be replaced in the near future, the 18" clay pipe that discharges into the box culvert should be repaired, (See Exhibit 9).
