Project Name: South Water Tower Rehabilitation Zip Code: 45322

On May 10, 2022, Dixon Engineering Inc. performed a maintenance inspection on the 1,000,000 gallon spheroid (South Tank) elevated water storage tank owned by the City of Englewood. Purposes of the inspection were to evaluate the interior and exterior coating's performance and life expectancy, assess the condition of metal surfaces and appurtenances, review safety and health aspects, and make budgetary recommendations for continued maintenance of the tank. All recommendations with budgeting estimates for repairs are incorporated in this report.

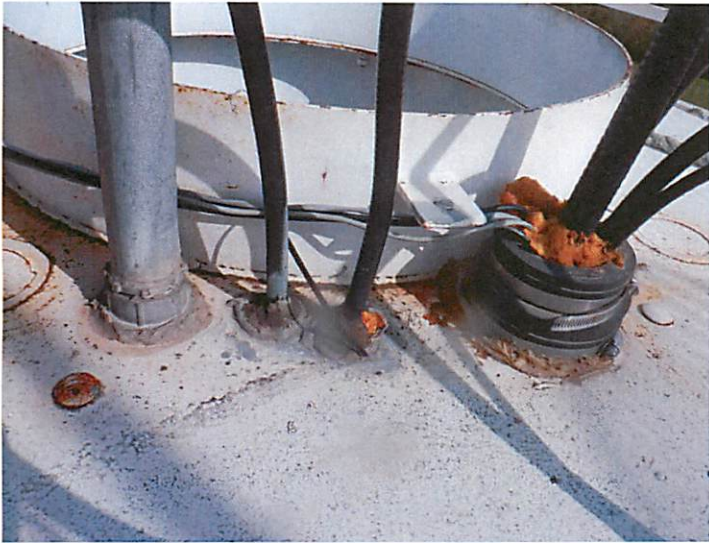
28) The roof cable penetrations are sealed with caulk and spray foam.

1. Continue to maintain the cathodic protection system. The cost would be dependent on your contract with your cathodic vendor.
2. Verify operation of the aviation lights. If operational, the lights should illuminate shortly after dusk. The work can be performed by in-house personnel from the ground.
3. Request that the antenna owners return to correct deficiencies in cable sealing. The cable penetrations should be sealed with caulk or rubber boots.

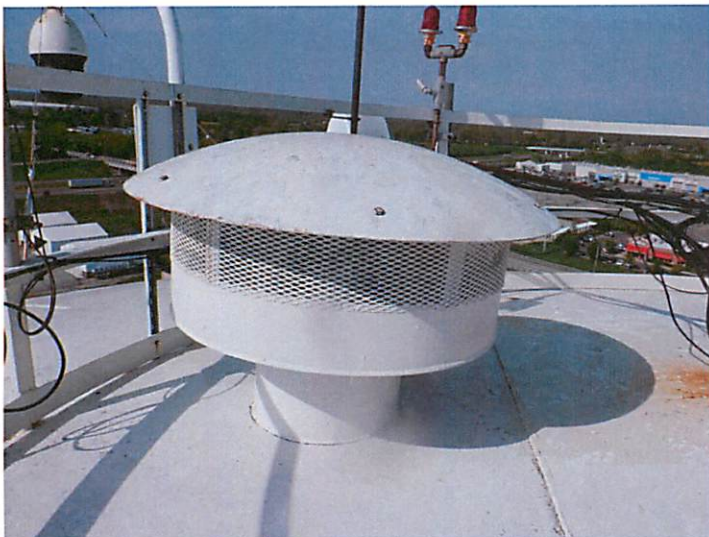
30) The roof vent is in good condition but there is no rain shield. The vertical expanded metal screen is in good condition.

1. Install a gasket on the wet interior roof hatch to meet current Ohio EPA requirements. The cost would be incidental to the next painting project or could be performed by in-house personnel.
2. Replace the roof vent with a pressure vacuum vent that has a rain shield to meet current Ohio EPA requirements. The estimated cost is \$6,000.

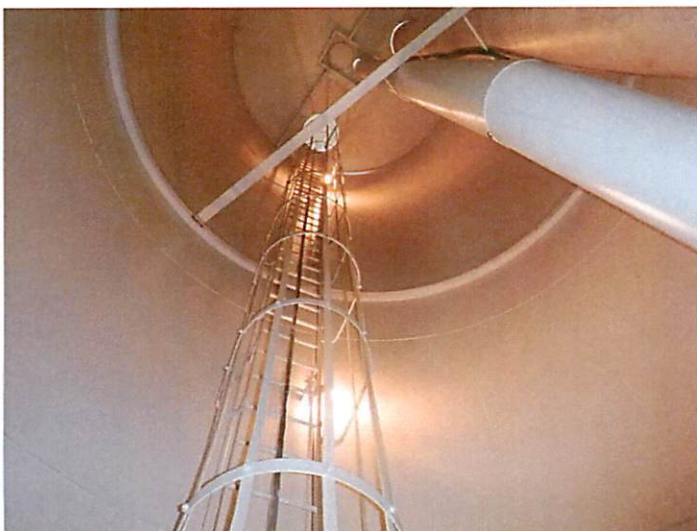
45) The riser ladder is in good condition. The ladder is equipped with a fall prevention device and is caged.

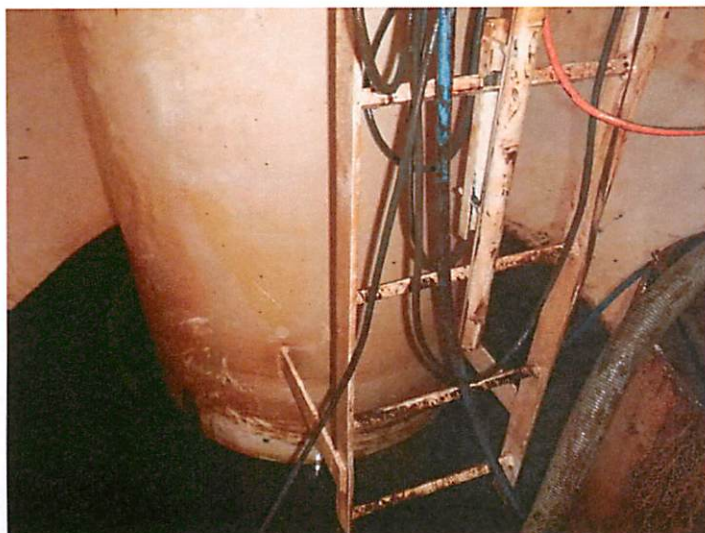
63) The wet interior ladder is in good condition. The ladder is equipped with a fall prevention device.
