Project Name: South Water Tower Rehabilitation Zip Code: 45322

On May 10, 2022, Dixon Engineering Inc. performed a maintenance inspection on the 1,000,000 gallon spheroid (South Tank) elevated water storage tank owned by the City of Englewood. Purposes of the inspection were to evaluate the interior and exterior coating's performance and life expectancy, assess the condition of metal surfaces and appurtenances, review safety and health aspects, and make budgetary recommendations for continued maintenance of the tank. All recommendations with budgeting estimates for repairs are incorporated in this report.

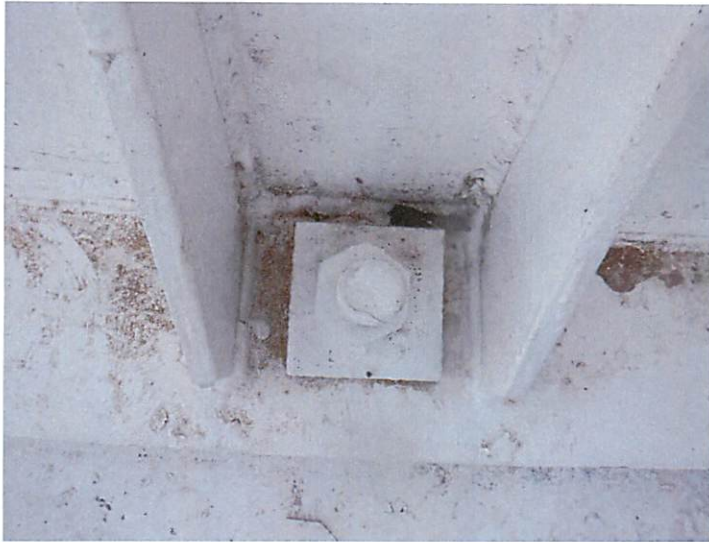
4) Same.

3) The basebell anchor bolts are in good condition.

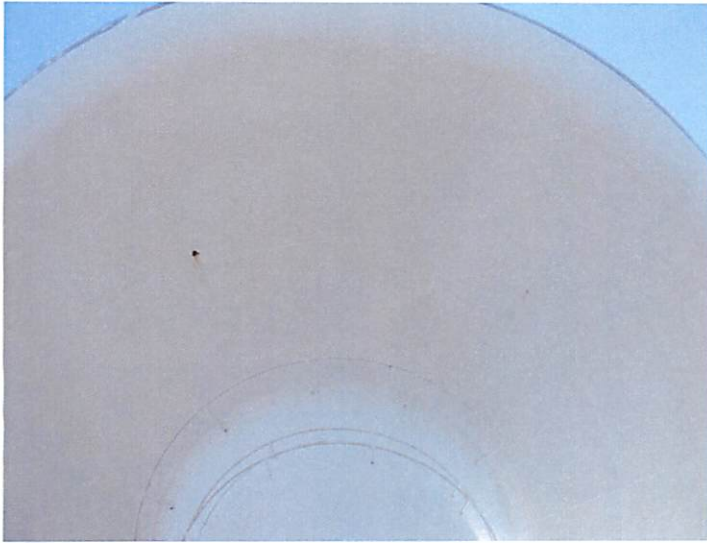
13) Same.

The bowl coating is in fair condition with a few failures. Primary method of deterioration is spot failures to the substrate.

12) The coating on the bowl is in fair condition with minor spot coating failures.

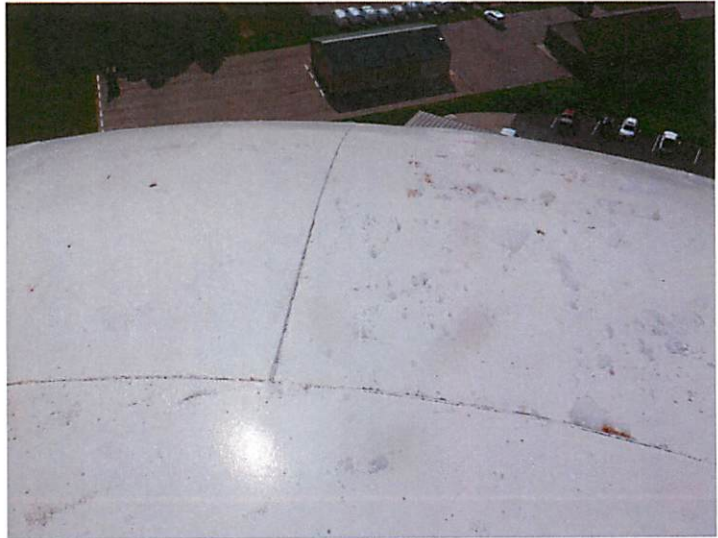
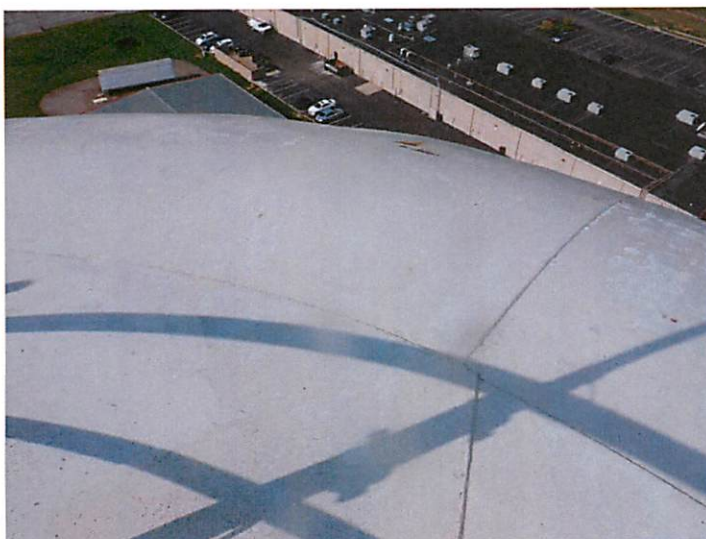
The roof coating is in fair condition with numerous failures. Primary methods of deterioration are spot failures to the substrate, rust bleedthrough, and topcoat delamination.

16) The coating on the roof is in fair condition with moderate failures.

Budget for total exterior coating removal and repainting in approximately five years or when aesthetics dictate. Fading will continue and more rust spots will occur decreasing the tank's aesthetic appearance.

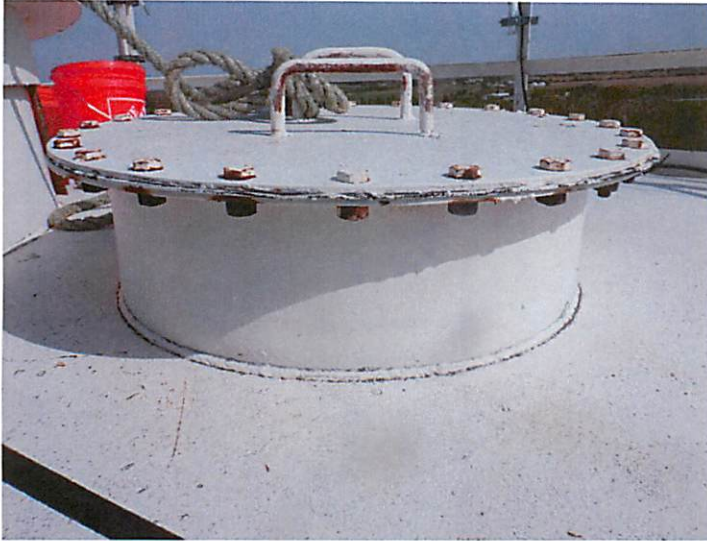
22) Same.

21) The bolted ventilation hatch is in good condition.

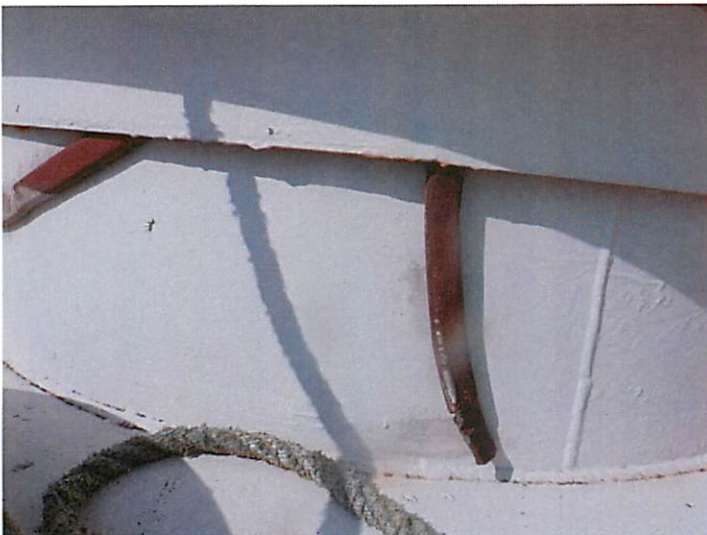
24) Same.

23) The access tube air gap was sealed with a gasket wedged into the opening. The gasket has come loose.

3. Replace the cover over the access tube air gap to meet current Ohio EPA requirements. The cost would be incidental to the next painting project.
4. Install a sample tap on the fill/draw pipe to meet current Ohio EPA requirements. The estimated cost is \$1,000.

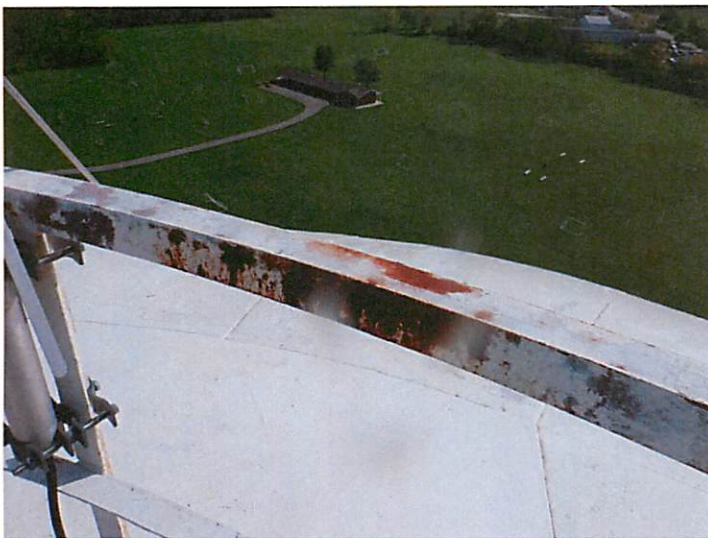
27) Same.

26) The roof handrail is in good condition. There are coating failures on the railing.

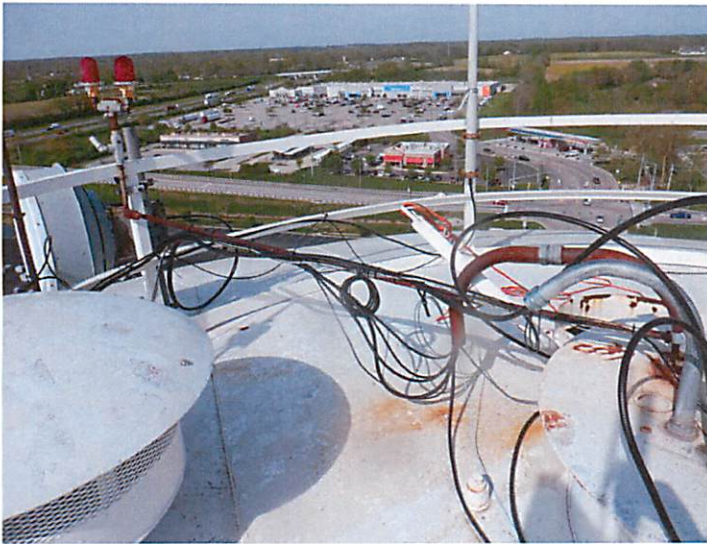
34) Same.

33) Antennas are mounted to the roof handrail.

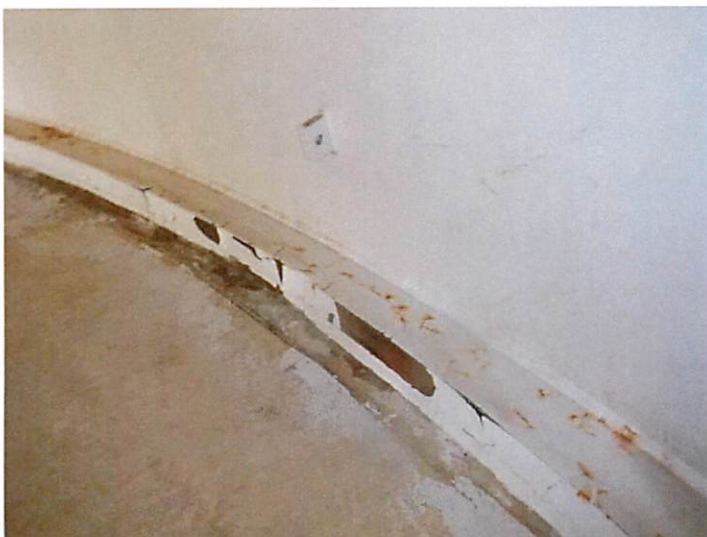
36) Same.

35) The basebell coating is in good condition with delamination on the baseplate.

2. Spot abrasive blast clean the topside of the platforms, the baseplate, and other spot coating failures in the dry interior. Spot repaint all prepared surfaces with an epoxy coating system. The estimated cost is \$20,000.

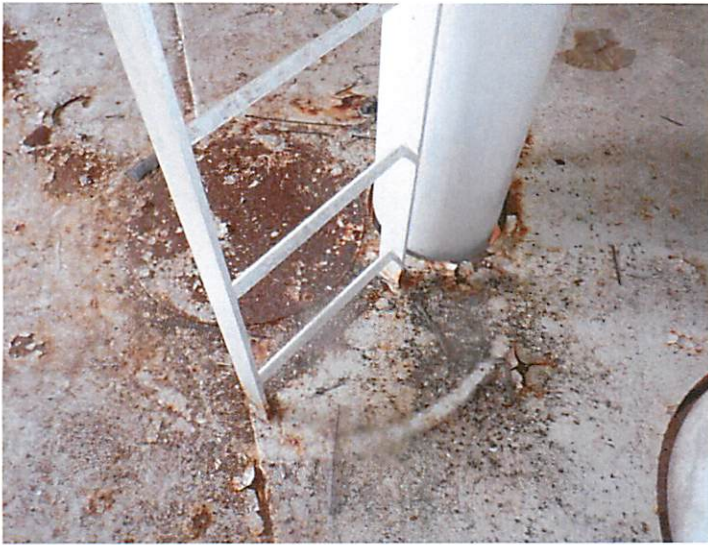
49) Same.

48) The coating on the top platform is in poor condition.

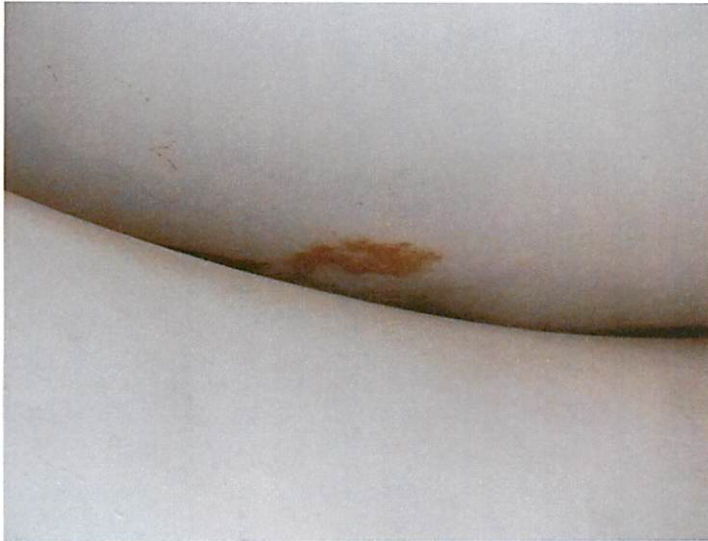
52) Same.

51) The coating on the riser above the top platform and the bowl is in good condition with minor failures.

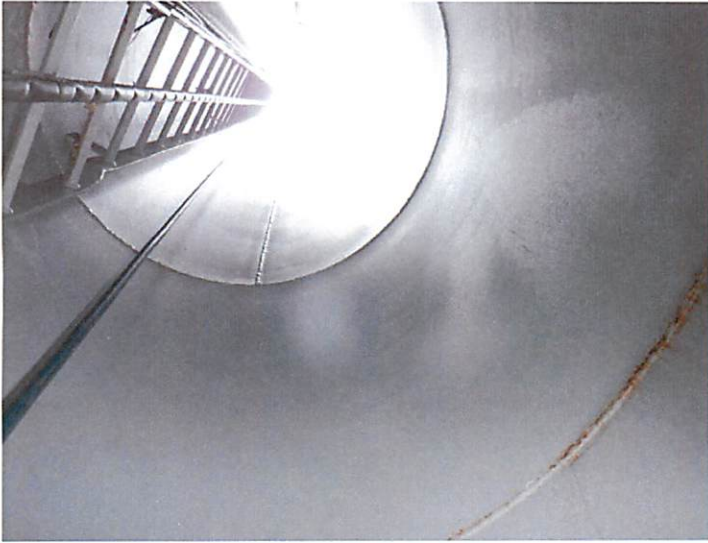
58) Same.

57) The access tube coating is in good condition.

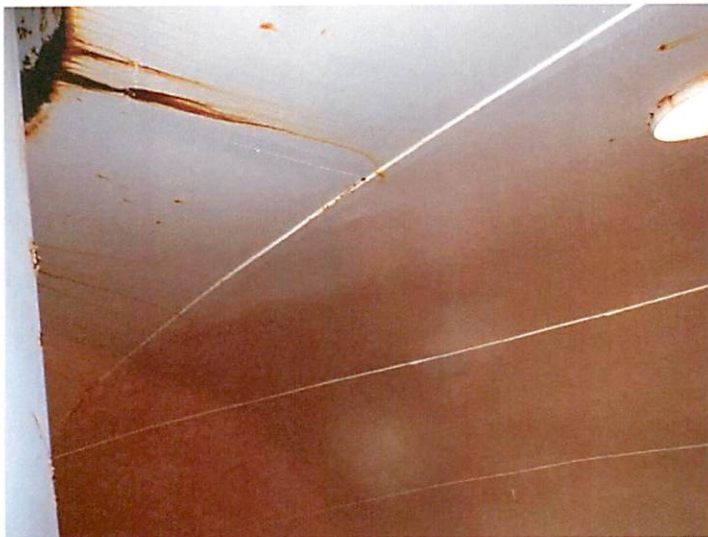
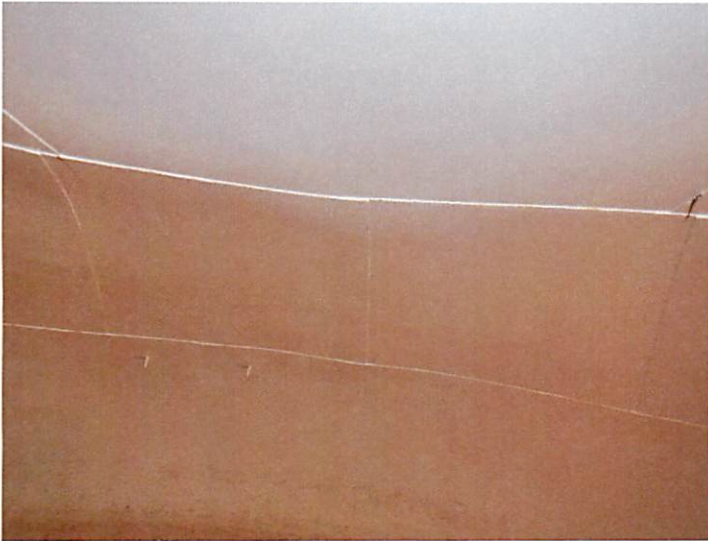
59) The wet interior roof coating is in good condition.

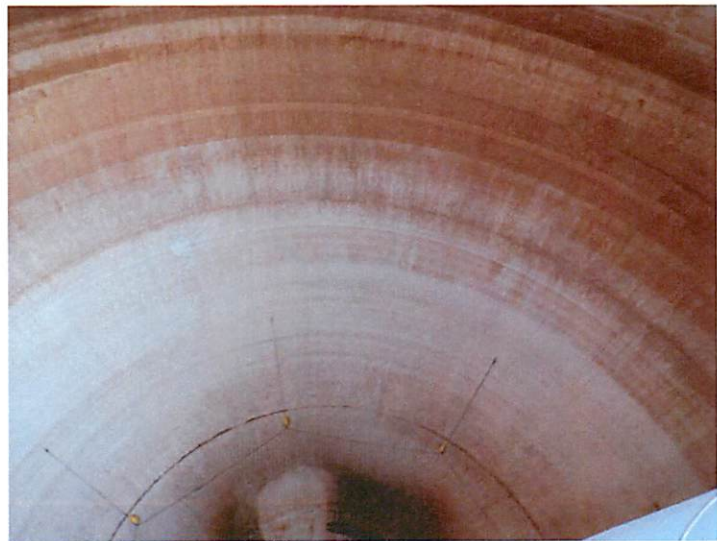
65) Same.

64) The coating on the sidewall is in good condition.

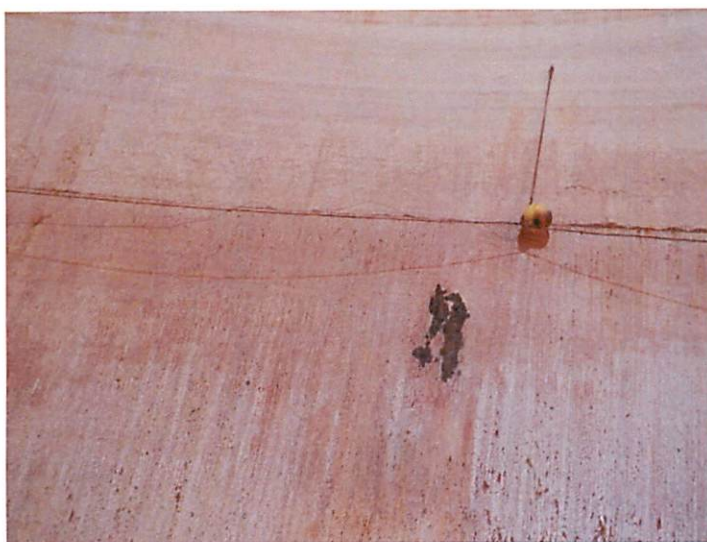
69) Same.

68) The cathodic protection system appears to be in good condition.

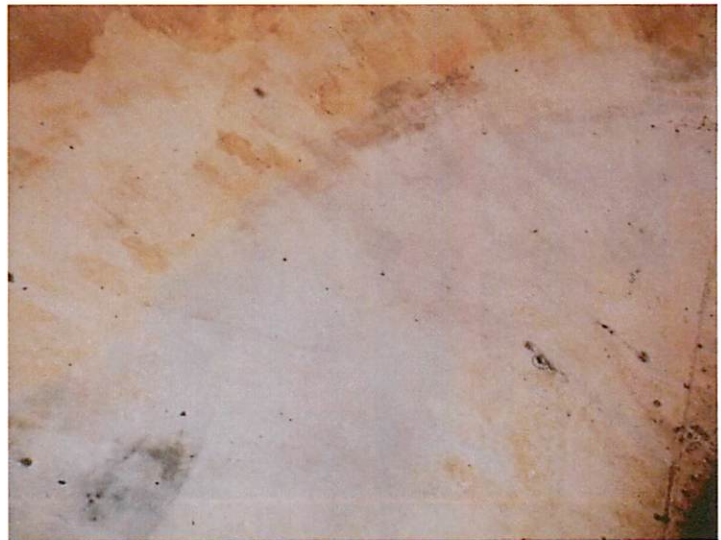
71) Same.

70) The coating on the bowl is in good condition overall with a few minor spot coating failures.

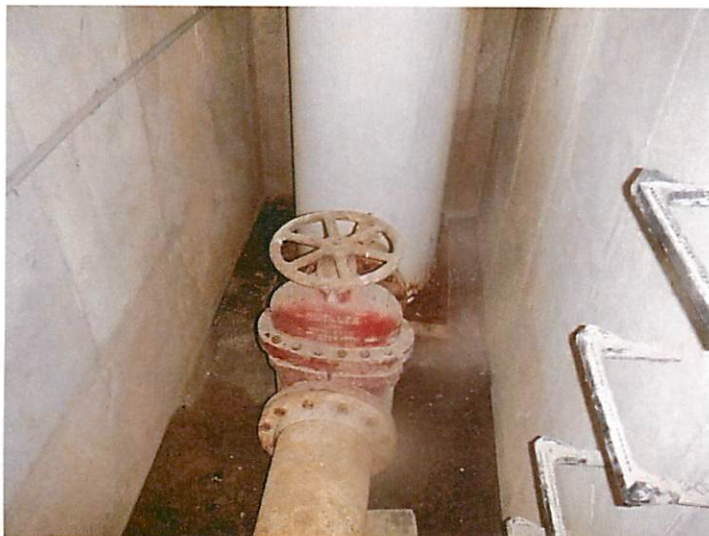
75) Same.

74) The coating on the pit piping is in fair condition.
